# Examples of Tire Conditions PLT

- › The EoTC is Continental's Tire Division exclusive reference document for tire condition definitions used in the warranty complaint handling process. It serves as a reference for selecting condition codes for complaints / adjustments and is to be applied by trained, qualified persons only (typically by the local TCS organization).

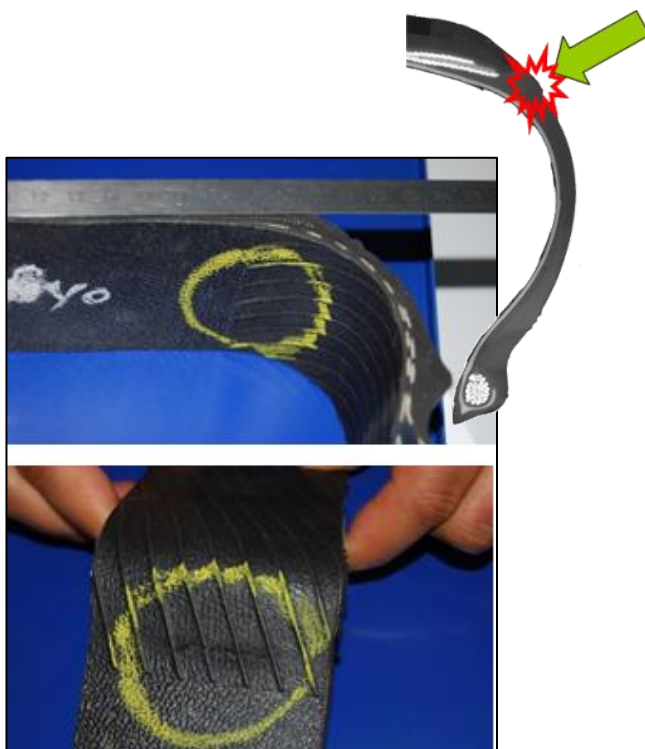
**CC121**

**Impact damage  
shoulder**

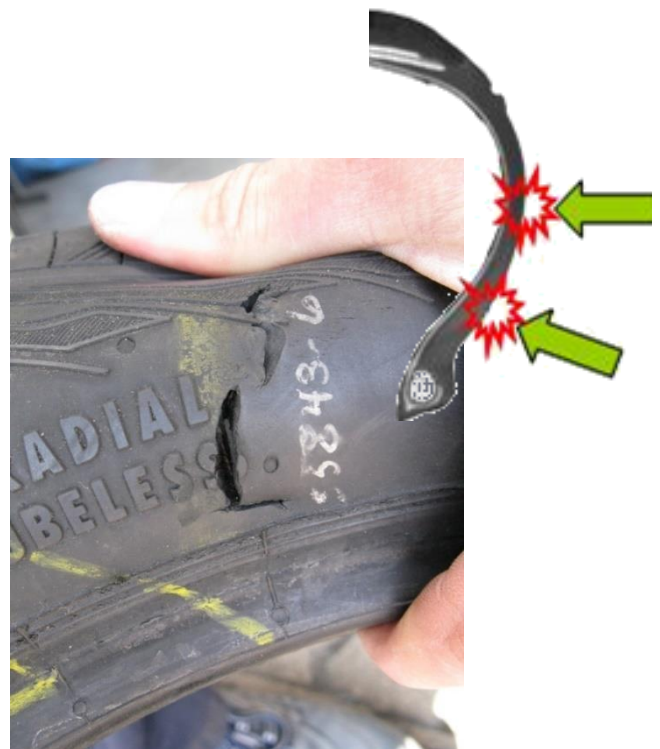
**Impact damage  
sidewall**

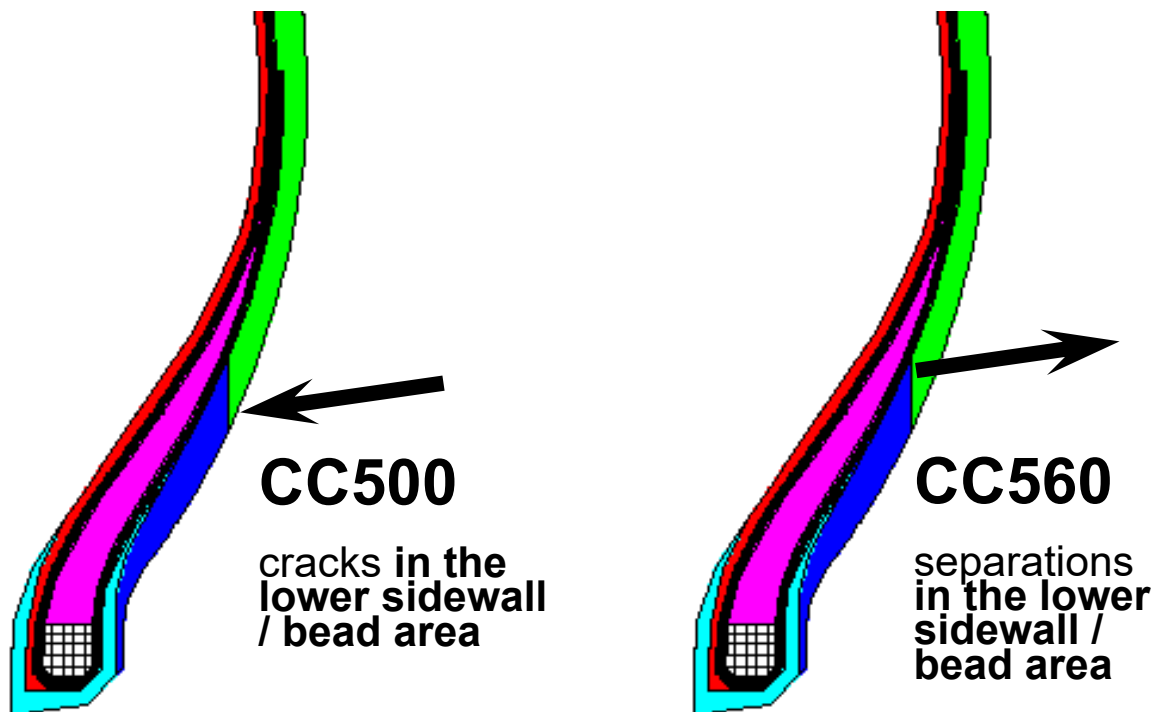
# definition of CC 500 versus 560

Cracks start on the outside of the tire.

Separations start inside the tire.

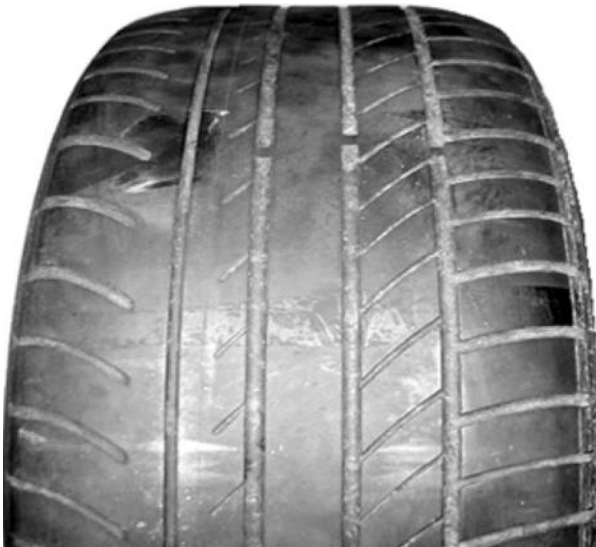
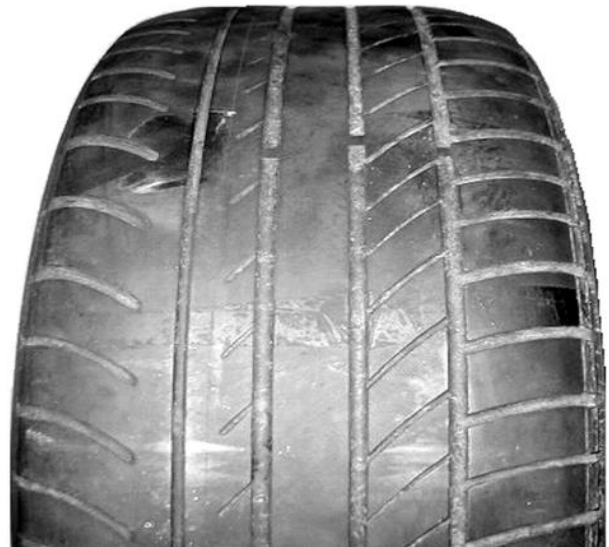
**EN****rapid wear****PLT**

Tire has worn out faster than expected with an even wear picture from shoulder to shoulder and circumferentially around the tire.

- \*Aggressive driving
- \*Abrasive road surfaces
- \*Weather conditions

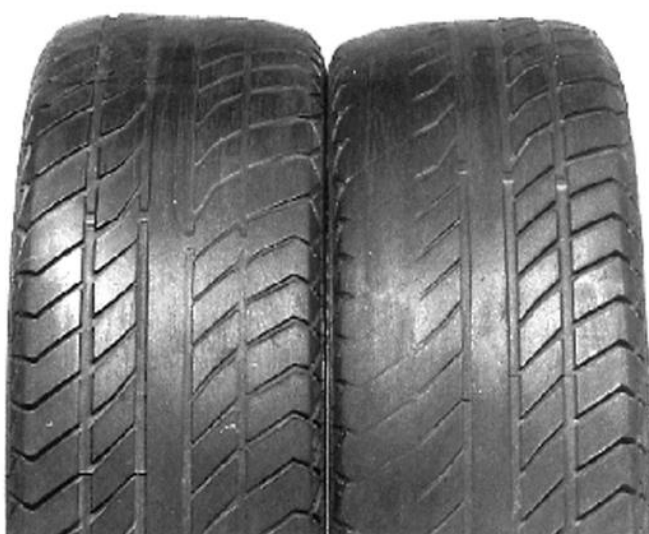
**EN****one sided wear****PLT**

Faster uneven wear on one side of the tire extending from the shoulder towards the center of the tread.

- \*Misalignment - front and/or rear axle
- \*loose front wheel bearings
- \*excessive axle loads
- \*loading conditions or road geometry (road camber, slope and or inclination)
- \*high stress due to camber settings (misalignment)

The difference between pronounced shoulder wear (both shoulders are affected) to one-sided wear is caused by disorder in mechanical geometry such as camber angle and/or road condition.

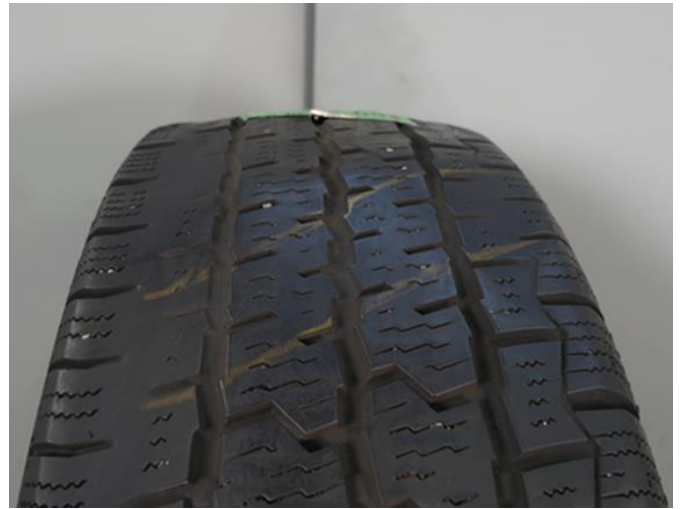
**EN****spotty, polygonal wear (wash out)****PLT**

Uneven spotty wear recurring around the tire's circumference.

- \*Underinflation
- \*Worn wheel bearing
- \*Imbalance
- \*Lack of shock absorber
- \*Flat spot
- \*Improper seating of the tire on the rim
- \*Improper seating of the wheel on the hub
- \*Defect with an ABS braking system
- \*Differences in diameter of fitted twin tires,
- \*Difference in remaining tread depth of fitted twin tires must be comparable e.g., <4mm for TT

There are different appearances for CC106, it can be e.g., worn inner ribs with signs of affected outer ribs, or worn spots in diagonal or polygonal form recurring around the tire's circumference.

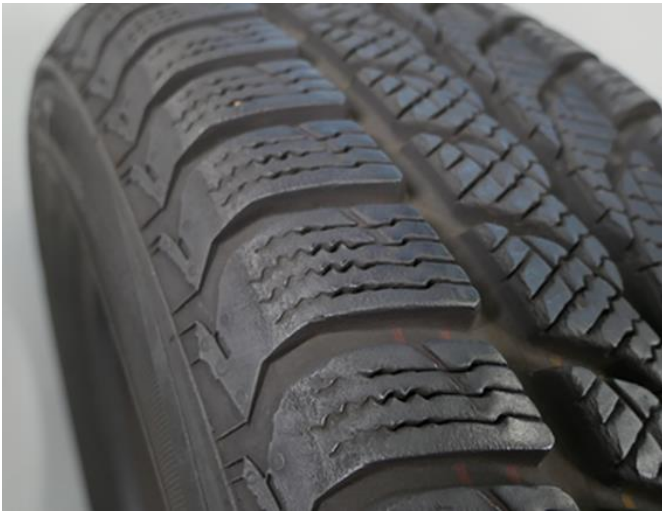
**EN****scale like wear****PLT**

The tread shows a very coarse wear pattern.

- \*strong lateral forces e.g., during lane changing
- \*maneuvering in the parking lot
- \*vehicle conditions
- \*climate
- \*driver style

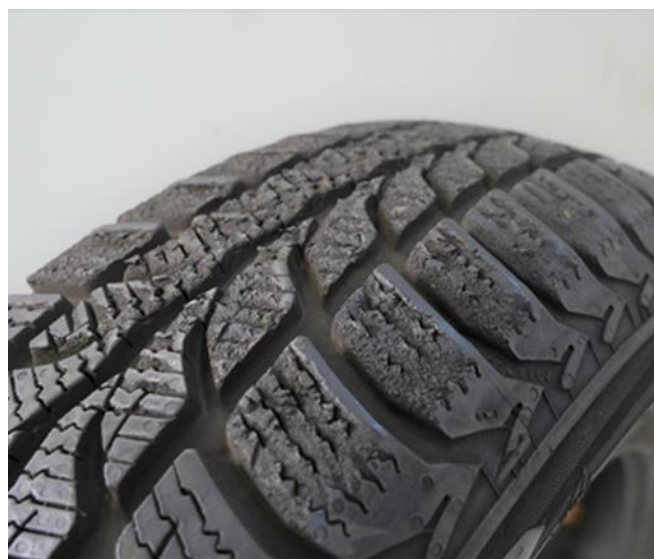
**EN****spot wear caused by locked wheel****PLT**

Local flat spot on tread surface that may extend into the casing. The localized wear equivalent to the size of the ground contact patch can have a coarse abrasion pattern, but the surface may seem smooth.

- \*Locked brake
- \*Broken ABS system

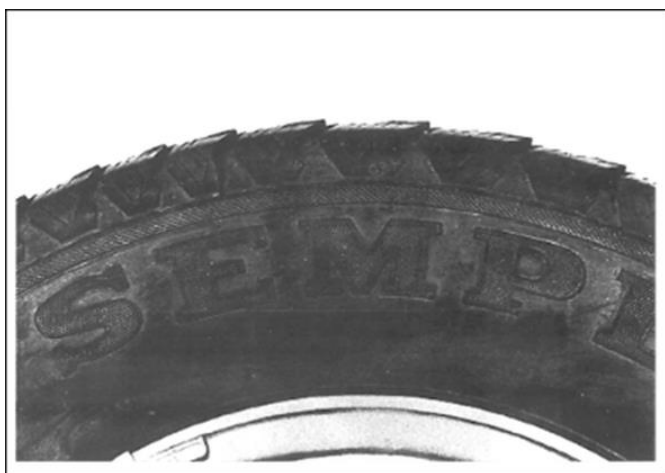
**EN****heel and toe wear****PLT**

“Saw tooth” tire wear, also known as “heel-toe wear,” is a type of uneven tire wear that results in a saw-like pattern on the tire tread circumferentially. This pattern typically occurs when the leading edges of the tread blocks wear down more quickly than the trailing edges

- \*Improper inflation pressure
- \*Improper tire rotation practices
- \*Poor suspension maintenance
- \*Mismatched tire diameters in dual assemblies.
- \*Misalignment

Often associated with ride disturbance and/or noise complaint. It usually happens on block-pattern (lug design) drive axle tires but may also be observed on rib-design tires with sipes in lateral direction.

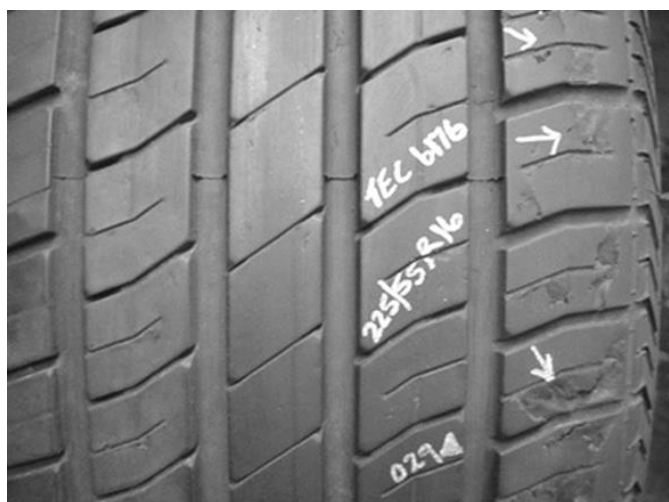
**EN****flaky wear/torn out blocks****PLT**

This is a condition where pieces of the tire tread break off creating a rough and uneven surface.

- \*frequent driving on rough unpaved or gravel surface road conditions
- \*exposure to high temperatures
- \*misapplication of the tire to service conditions.

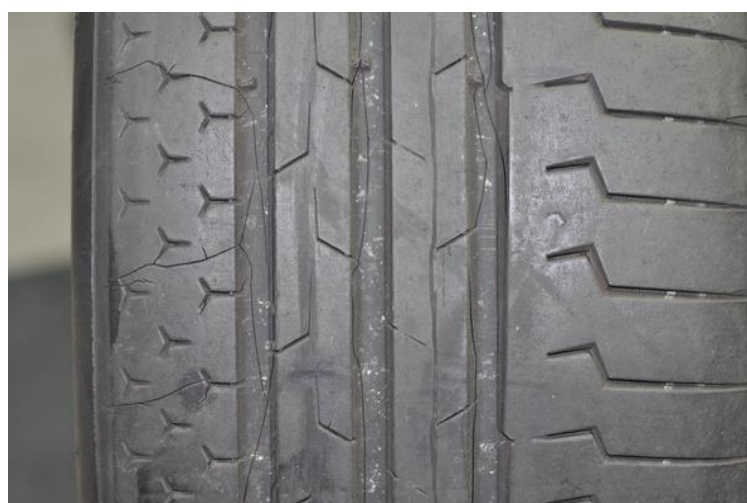
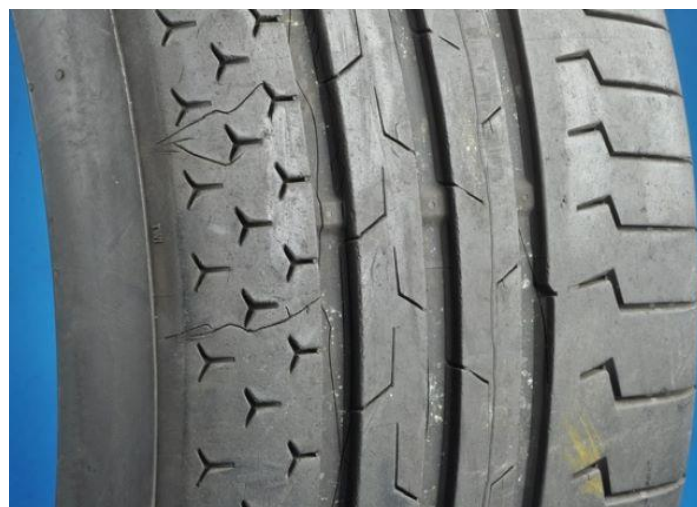
**EN****brittleness cracks in tread (PLT and TT only)****PLT**

Utilization of summer tires or UHP tires predominantly UHP tires at very low ambient temperatures

\*Cracks due to very low ambient temperatures

In extreme low ambient temperatures, the rubber compounds in tires can harden, making them less flexible and more prone to cracking. Brittleness cracks usually start on the tread area and propagate to other areas of tire such as sidewall. Repeated heating and cooling in thermal cycles can cause the rubber to expand and contract, leading to the development of cracks over time. Use of Winter Tires designed to remain flexible in low temperatures may reduce the risk of cracking.

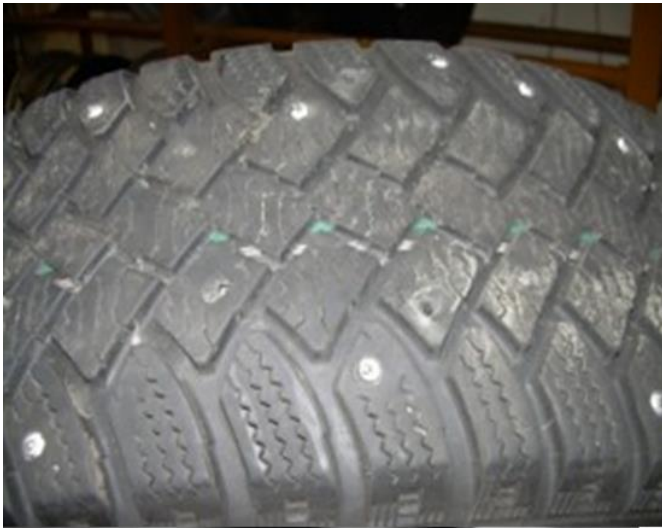
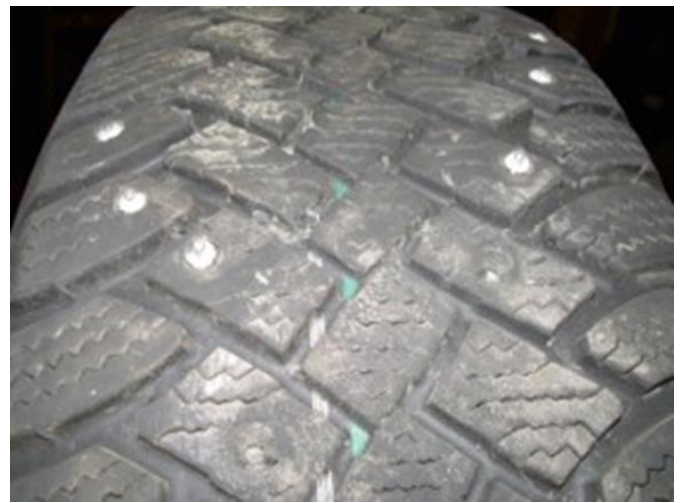
Spikes are missing. On the tread area some spots are visible where spikes were located.

- \*Driving at high speeds, hard braking or aggressive cornering especially on bare pavement
- \*Driving frequently on dry or rough surfaces
- \*Underinflated tires can flex more, increasing the movement of studs within their sockets.

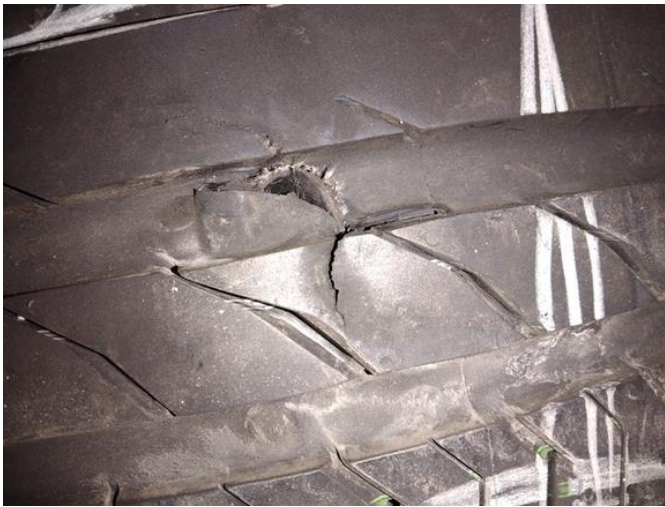
**EN****impact damage (tread)****PLT**

Localized area of damage to the main structure of the tread area. It is a break through the tread rubber and the casing.

Tire tread striking a hard object usually followed by IPL (Instantaneous Pressure Loss). A hard impact compresses the tire, causing the cords or steel belts inside to break

Internal layers e.g., belt wires are exposed and in some cases wire ends are frayed.  
Please do not mix this condition with the escalation of CC128. In such cases use CC128 in CC1 and use CC119 in CC2 for cases where you have an impact break associated with damages through deep cuts into the tread/belt.

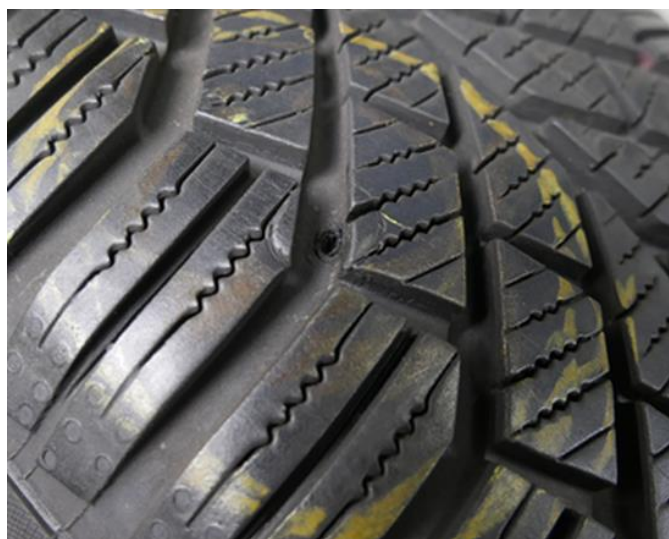
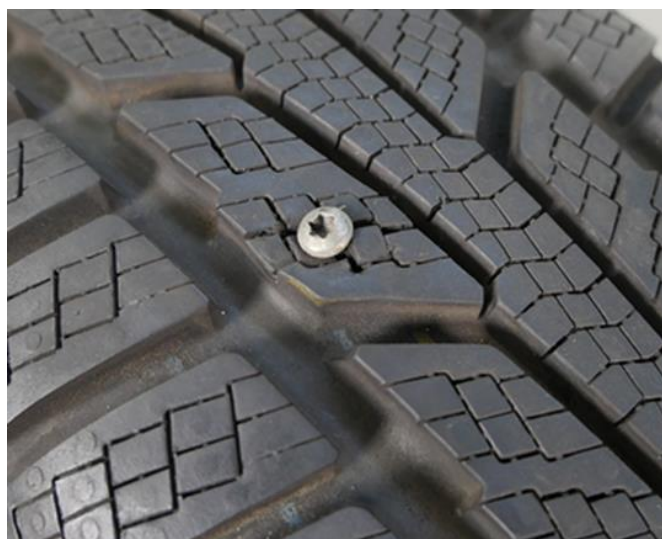
A sharp object e.g. nail or screw penetrated the tread area/innerliner.

\*Punctured by a sharp object

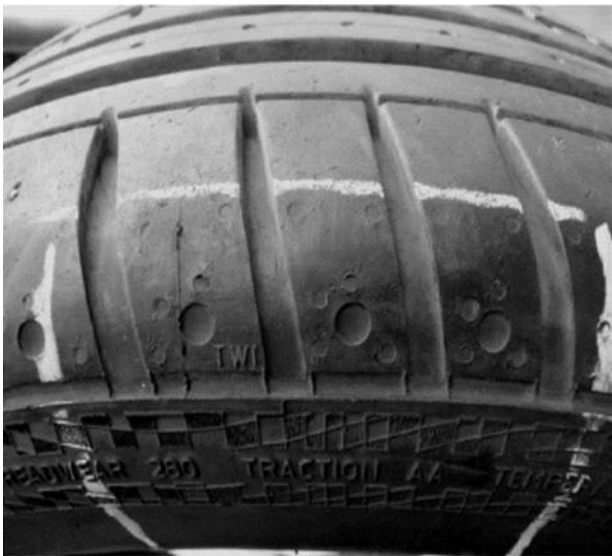
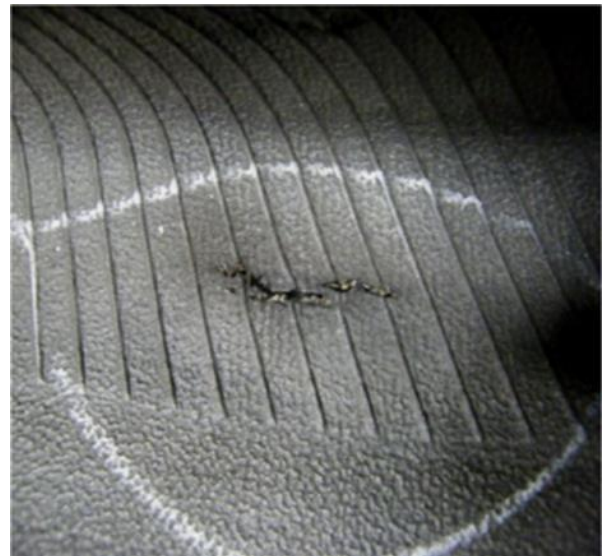
**EN****impact damage (shoulder)****PLT**

Localized area of damage to the main structure of the shoulder

Tire shoulder striking a hard object usually followed by IPL (Instantaneous Pressure Loss). A hard impact compresses the tire, causing the cords or steel belts inside to break.

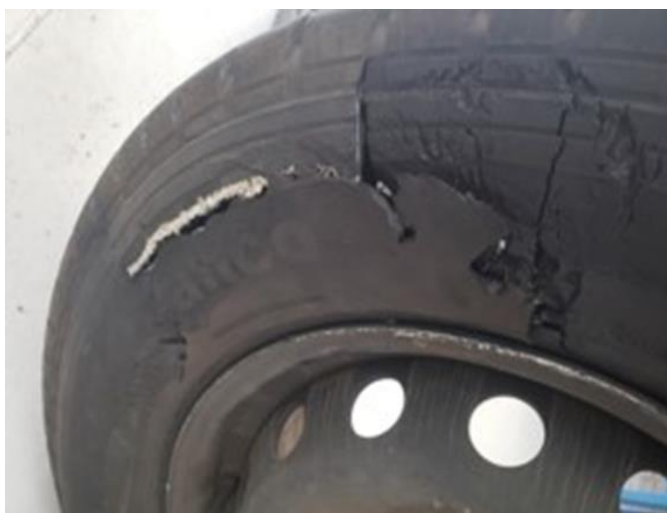
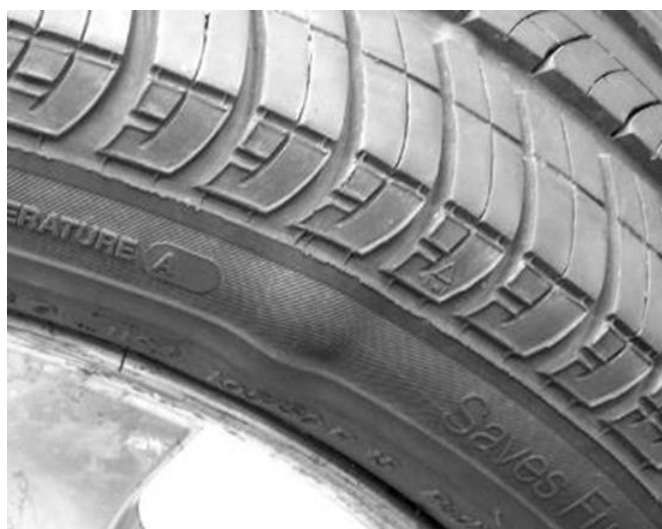
Localized area of damage to the main structure of the sidewall. Bulges might be found.

- \*An impact break on the sidewall of a tire occurs when the tire strikes a hard object, e.g., curbstone or pothole, with enough force to damage its structure.
- \*Double fracture of the tire's casing suggests that the sidewall has been "pinched" between the wheel rim flange and a solid angular object such as a curbstone.

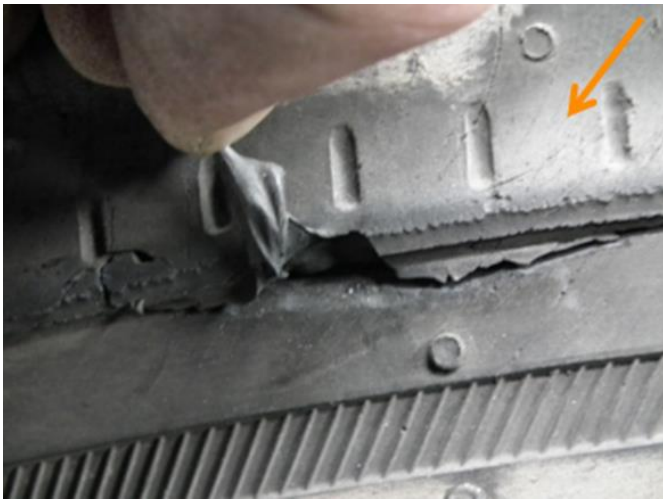
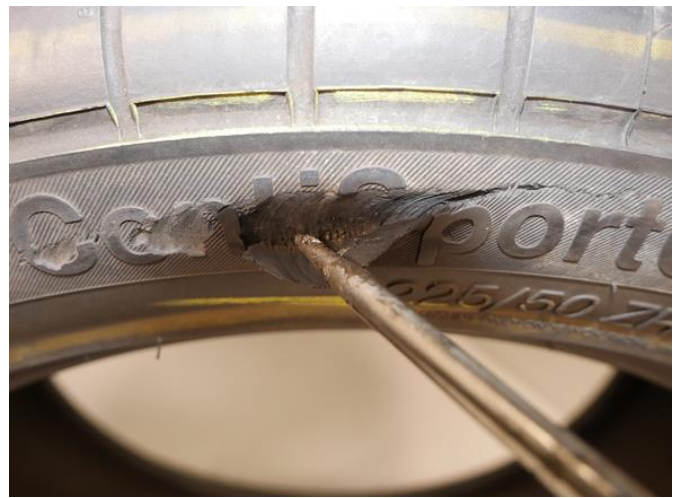
The tire has sustained a cut to the sidewall /shoulder from a sharp, foreign object (e.g., glass or metal). This can be manifested in areas of tearing of the rubber compound.

Cut damage is caused by sharp objects and results in slits or tears on the tire surface, which may or may not reach the inner layers of the tire, depending on their depth.

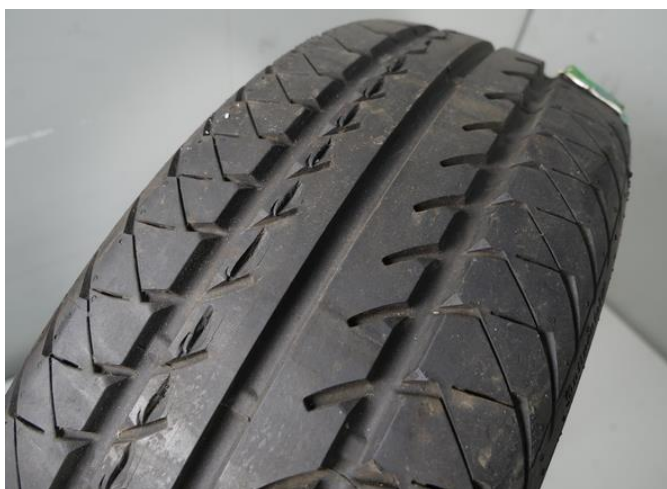
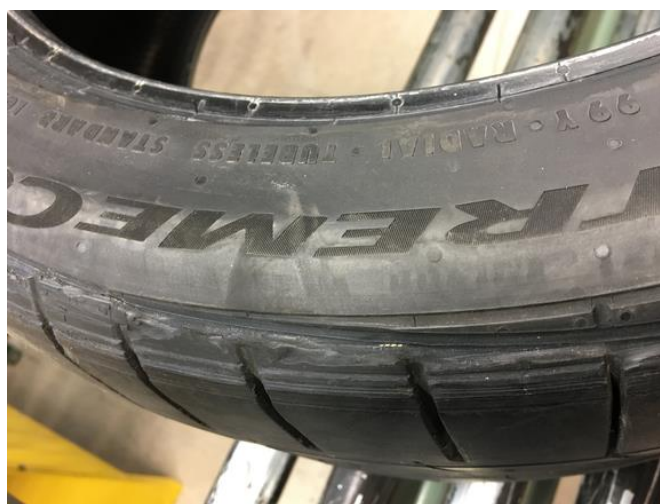
The tire has suffered 'scoring' damage by any vehicle part(s) that has touched any part of the tire such as tread or sidewall and caused carving or abrasion there in a certain pattern.

- \*Loose or protruding object on the vehicle
- \*Foreign object picked up from the road surface which then became embedded in the bodywork (e.g., wheels spinning on rough surface, trapped material between tire and vehicle part)

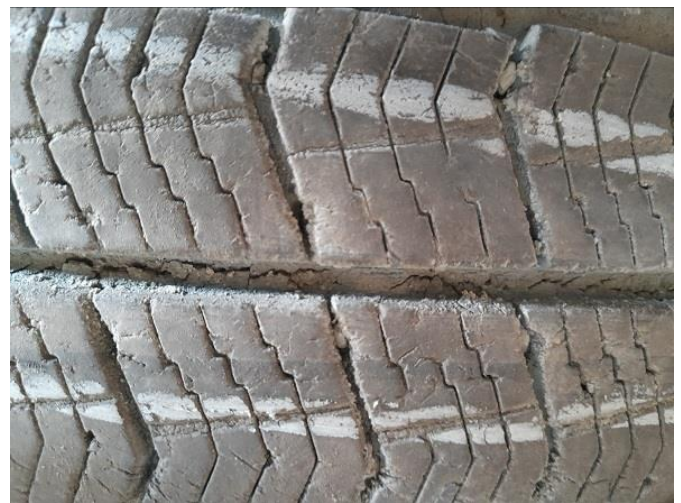
The tire has sustained deep cuts by a sharp or a hard foreign object to the tread that reach the steel reinforcing cords (e.g., belt layers)

\*Cut damage through the outer rubber layer reaching out to internal components (e.g., belts) damaging and exposing it to corrosion.

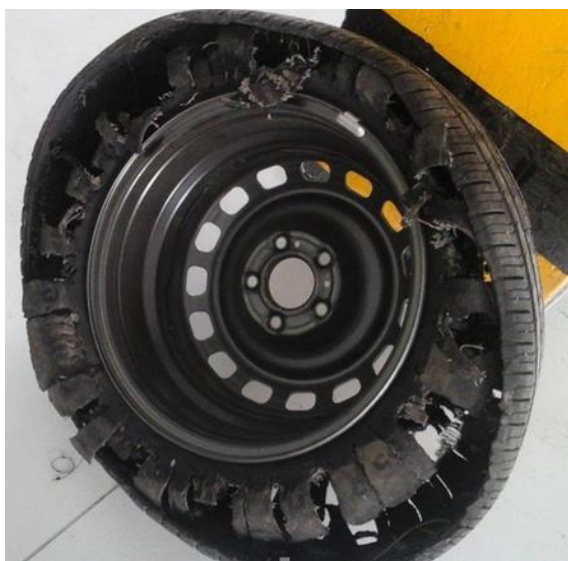
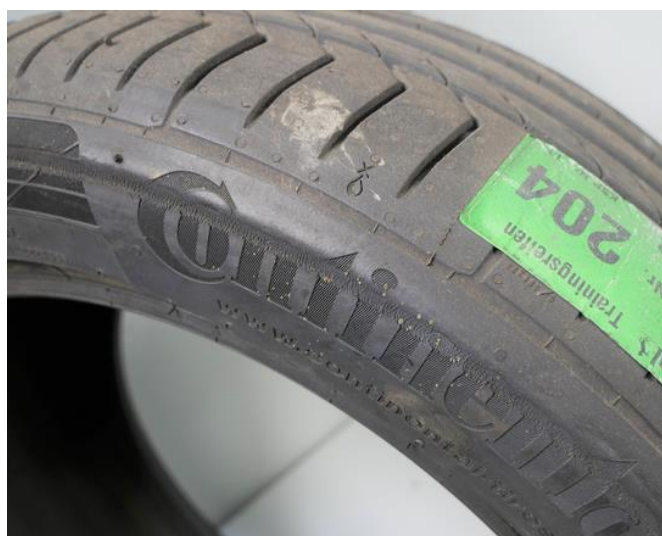
Advanced deterioration of radial tire affecting tire sidewall. The tire exhibits a dark abraded stripe (discoloration); blister, scorched (burned), breaks, wrinkles and/or separation of innerliner are circumferentially around and inside tire sidewall. In well advanced stages, the tire will lose its tread and/or belt package.

- \*Running in a totally deflated condition caused by e.g., either a puncture or rim condition, however due to the extent of damage any clues to the original cause of deflation/instantaneous air loss cannot be found.
- \*Underinflation
- \*Overloading

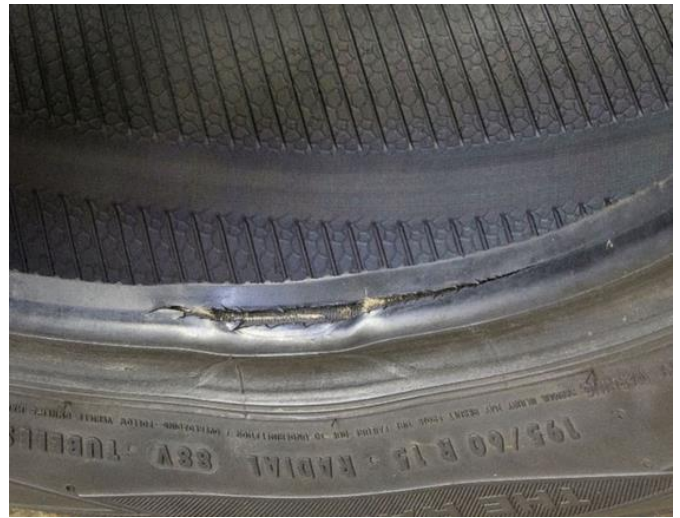
The bead of the tire has been locally torn away and signs of separation of internal components can be seen. Dents on local spots due to tools used during mounting maybe observable

- \*Damaged during the fitting operation
- \*Improper usage of lubricants and fitting tools (e.g., sharp edged)

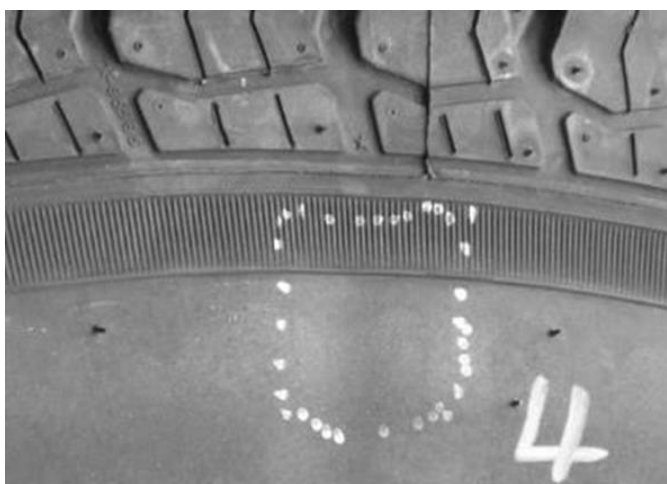
Sidewall undulation is visible after inflation. The undulations are local strong points.

\*Thickness which is a double layers of casing material at a joint which resists the effect of inflation more than the surrounding area.

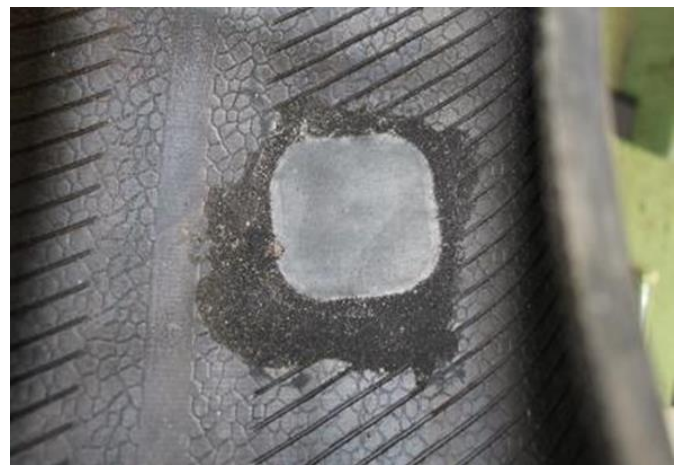
The tire has previously suffered a damage which has been repaired. Repair patches are visible.

\*Related to original damage or the repair

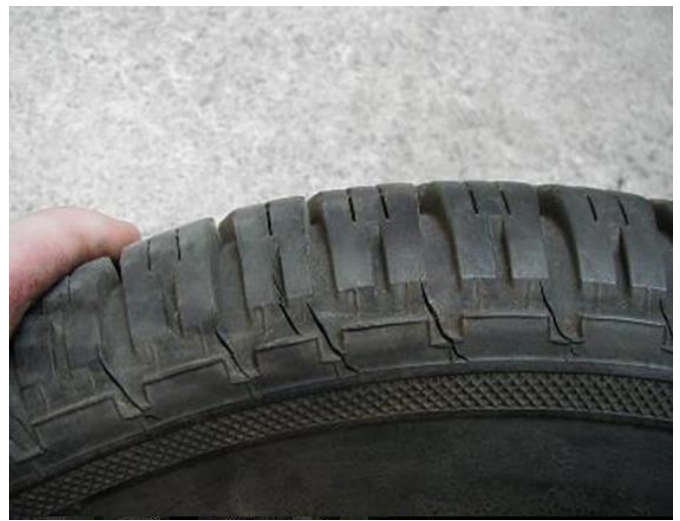
Cracks in the shoulder area. They are located above or in the mold parting line. The regular flow is typically in circumferential direction. It is shallow, open just from outside. Split surface is plain and it has no traces.

- \*Possible adhesion deficiency between sidewall and tread
- \*Break in flexing zone

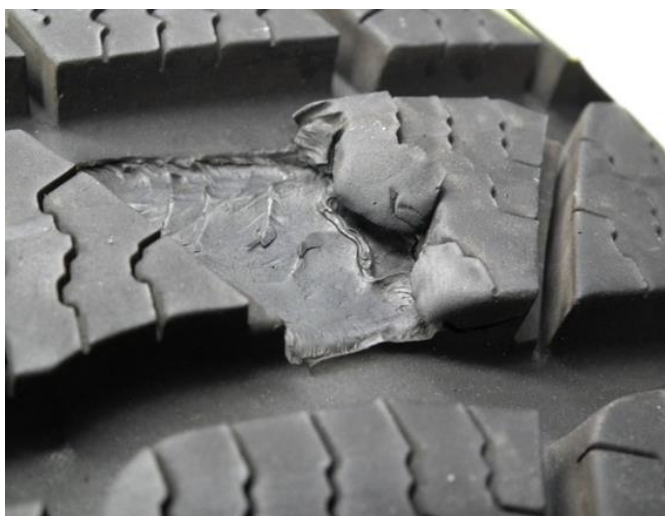
Pattern blocks are torn off at the base of the tread. There are big parts or whole blocks tearing off.

\*Material or demolding process related

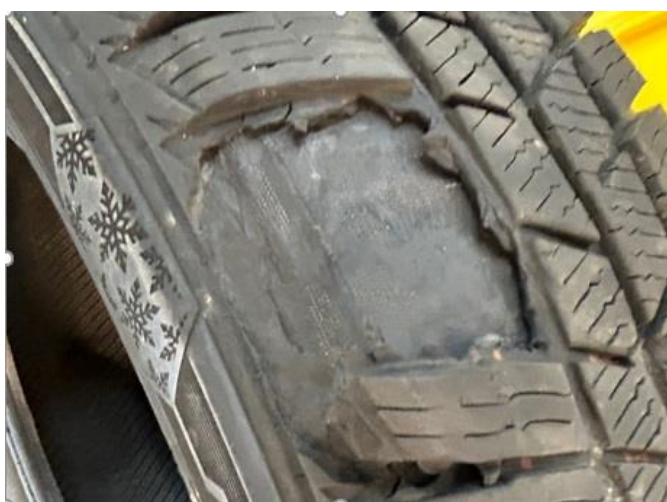
Tread ribs or blocks are not adhered on the belt package. A localized wear on the tread above the separated area can be noticed. One may easily observe a shiny spot underneath the separated tread elements. The belt package is expected to be intact.

\*Adhesion loss between the tread rubber and the tire belt package.

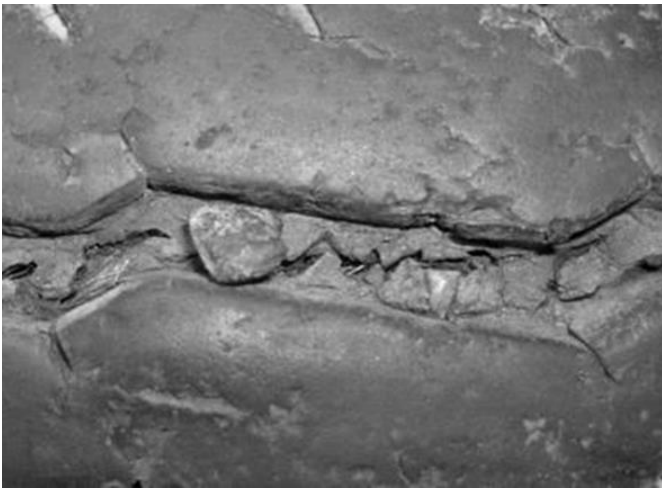
Areas at the base of the grooves with cracks and stones/ hints of stones.

- \*Stone retention, tread groove design related.
- \*Small stones become wedged in the tread grooves and exert continuous pressure on the rubber, leading to localized stress and cracking.
- \*Cracks can deepen over time, reaching the tire's belts or inner layers, compromising its strength.
