# Examples of Tire Conditions PLT

- › The EoTC is Continental's Tire Division exclusive reference document for tire condition definitions used in the warranty complaint handling process. It serves as a reference for selecting condition codes for complaints / adjustments and is to be applied by trained, qualified persons only (typically by the local TCS organization).

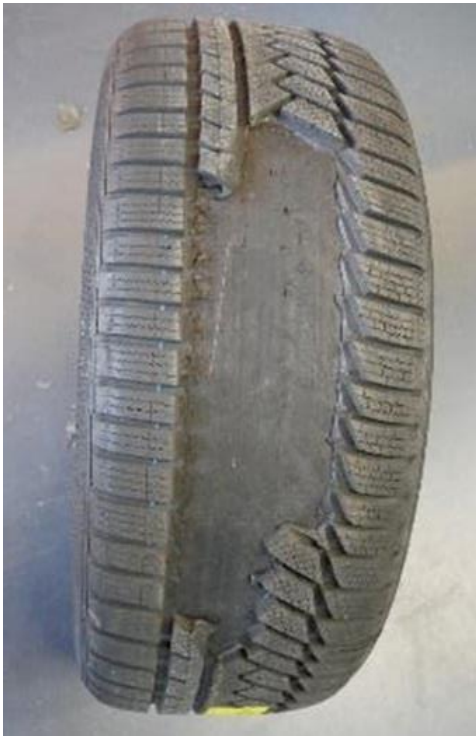
### CC210

Tread Lift / - separation  
starts from inside the tread

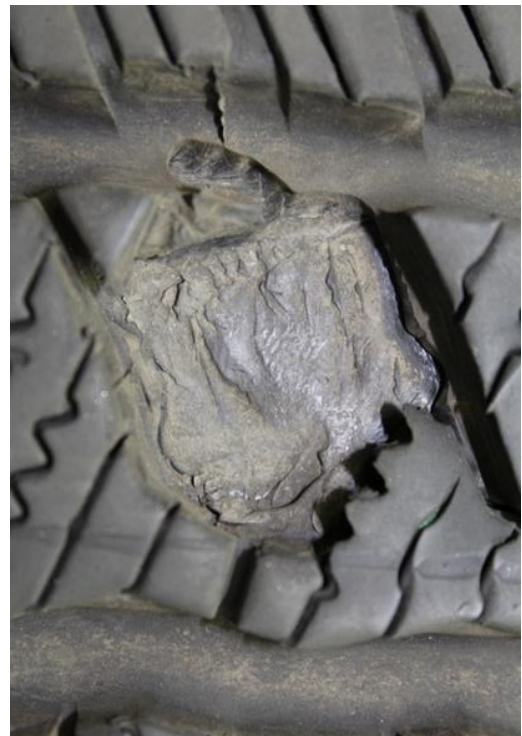
### CC206

Tread Chunking / Pattern  
Tearing starts from outside  
the tread

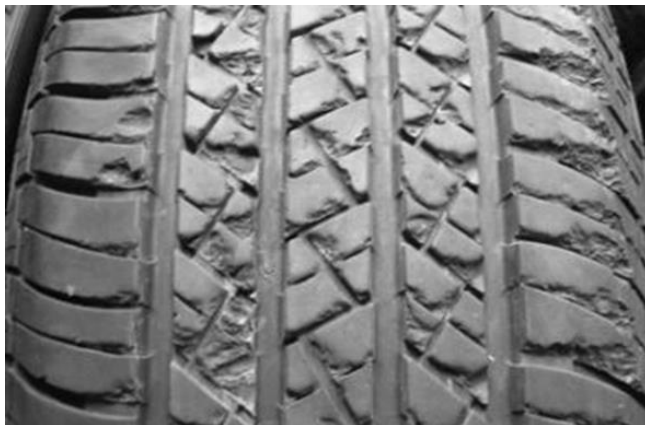
### CC216

Tread Flaking/-Chipping is  
in the compound surface

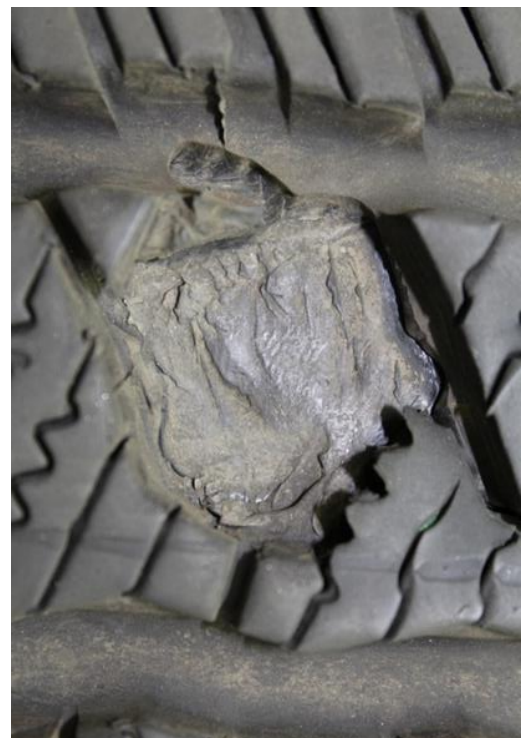
### CC206

Tread Chunking/ Pattern  
Tearing - pattern elements  
are torn out

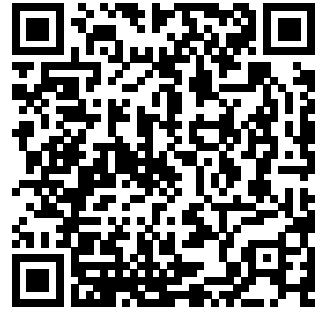
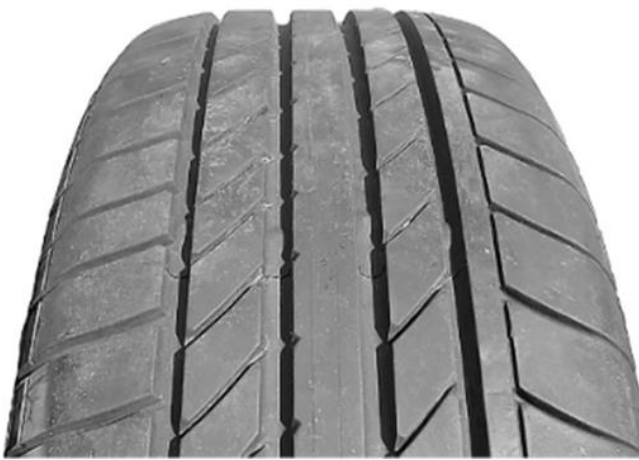
**EN****normal wear****PLT**

Tire has worn out with an even wear picture from shoulder to shoulder and circumferentially around the tire. The tread wear pattern appears normal for this type of tire.

\*Normal tire wear

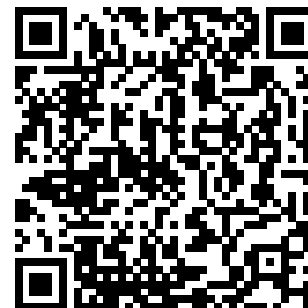
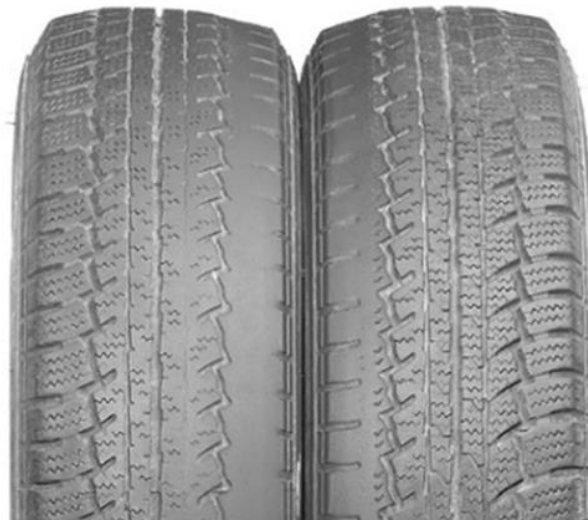
**EN****one sided wear****PLT**

Faster uneven wear on one side of the tire extending from the shoulder towards the center of the tread.

- \*Misalignment - front and/or rear axle
- \*loose front wheel bearings
- \*excessive axle loads
- \*loading conditions or road geometry (road camber, slope and or inclination)
- \*high stress due to camber settings (misalignment)

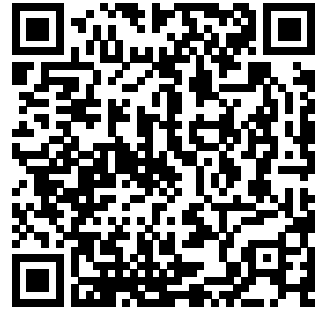
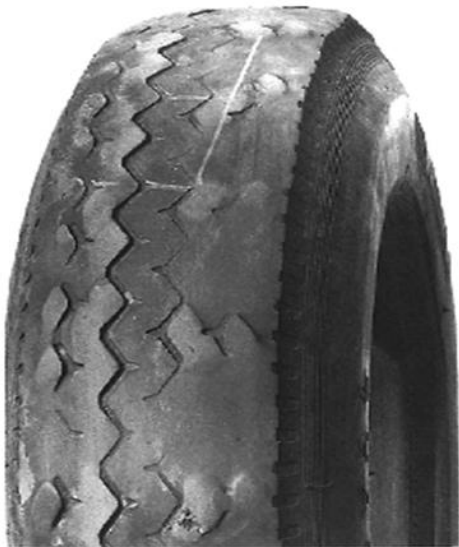
**EN****uneven wear around circumference****PLT**

Faster uneven wear of a portion of the tread circumference compared to the rest of the tread.

- \*Imbalance of tire / wheel assembly
- \*Tire not seated correctly on rim
- \*Defect suspension system (e.g., bearings, springs)

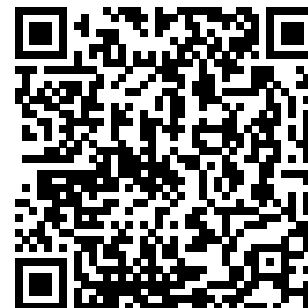
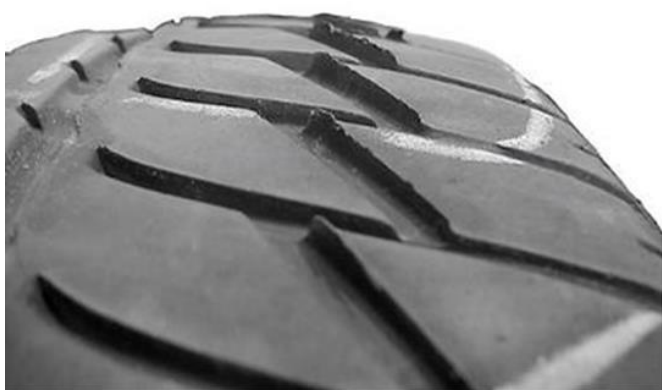
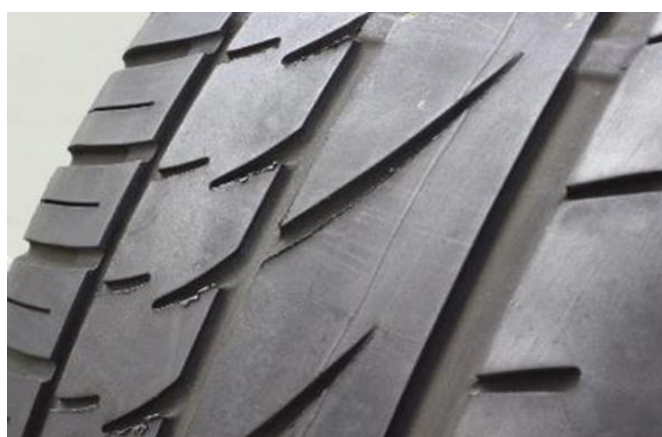
**EN****feather edged wear****PLT**

Irregular wear (high to low) of tread elements across the tread face. One edge of each rib is higher than the other side of the same rib. The edges are sharp.

- \*Misalignment / excessive toe
- \*Bent vehicle frame or chassis
- \*Hard (aggressive fast) cornering
- \*Missing or damaged suspension components
- \*Misapplication

Check suspension/track alignment settings  
Please note once this type of wear pattern has developed, correction of suspension/track alignment settings will only help prevent future uneven wear, and not correct the current worn tire.

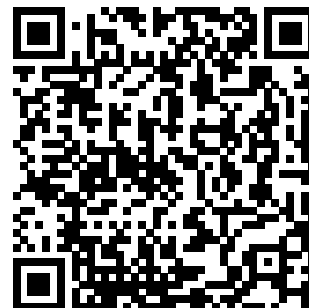
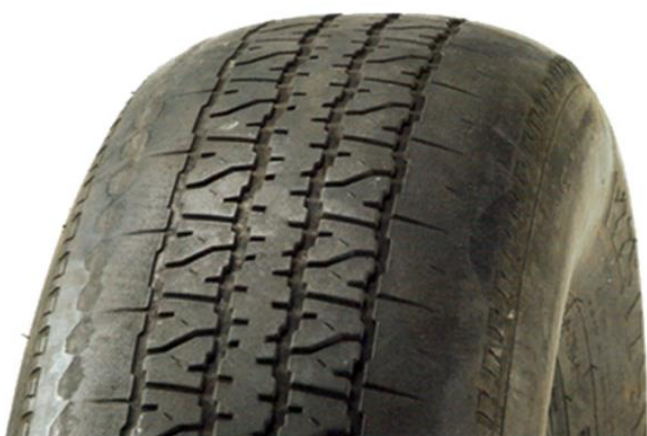
**EN****pronounced shoulder wear****PLT**

Faster wear of both shoulders compared to the adjacent tread surface.

- \*Underinflation
- \*Overloading
- \*Improper tire rotation practices
- \*Hard cornering

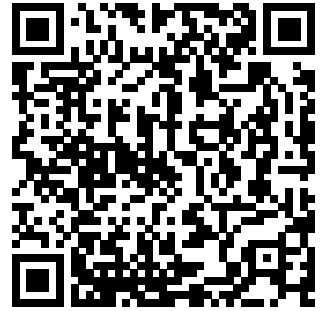
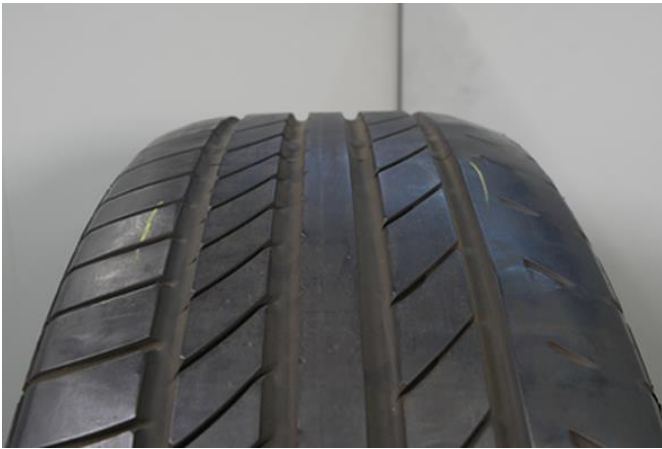
**EN****spotty, polygonal wear (wash out)****PLT**

Uneven spotty wear recurring around the tire's circumference.

- \*Underinflation
- \*Worn wheel bearing
- \*Imbalance
- \*Lack of shock absorber
- \*Flat spot
- \*Improper seating of the tire on the rim
- \*Improper seating of the wheel on the hub
- \*Defect with an ABS braking system
- \*Differences in diameter of fitted twin tires,
- \*Difference in remaining tread depth of fitted twin tires must be comparable e.g., <4mm for TT

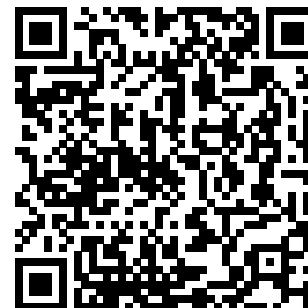
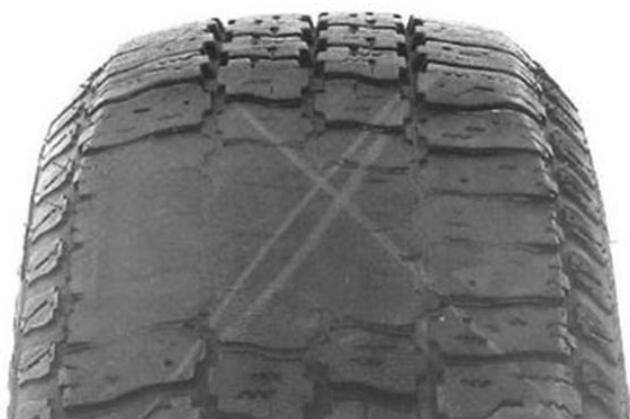
**EN****spot wear caused by locked wheel****PLT**

Local flat spot on tread surface that may extend into the casing. The localized wear equivalent to the size of the ground contact patch can have a coarse abrasion pattern, but the surface may seem smooth.

- \*Locked brake
- \*Broken ABS system

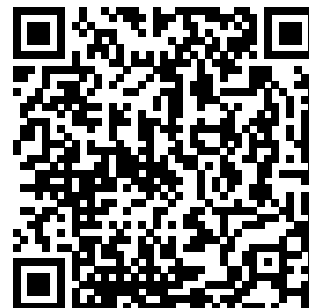
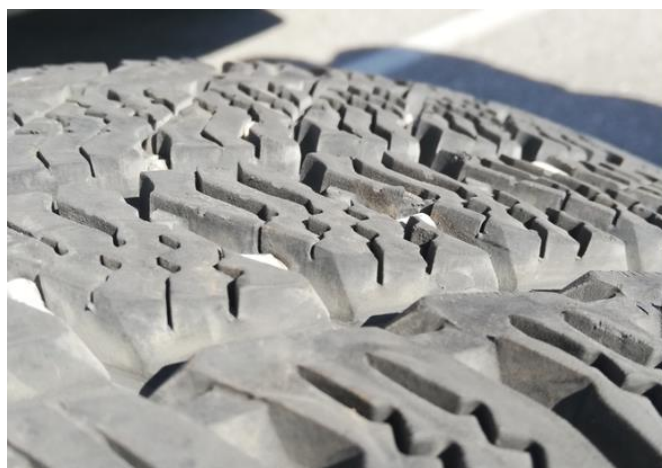
**EN****heel and toe wear****PLT**

“Saw tooth” tire wear, also known as “heel-toe wear,” is a type of uneven tire wear that results in a saw-like pattern on the tire tread circumferentially. This pattern typically occurs when the leading edges of the tread blocks wear down more quickly than the trailing edges

- \*Improper inflation pressure
- \*Improper tire rotation practices
- \*Poor suspension maintenance
- \*Mismatched tire diameters in dual assemblies.
- \*Misalignment

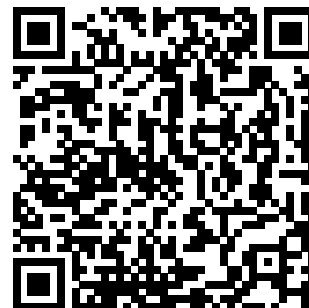
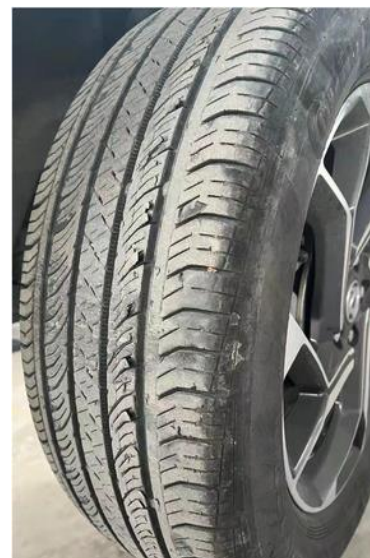
This is a condition where pieces of the tire tread break off creating a rough and uneven surface.

- \*frequent driving on rough unpaved or gravel surface road conditions
- \*exposure to high temperatures
- \*misapplication of the tire to service conditions.

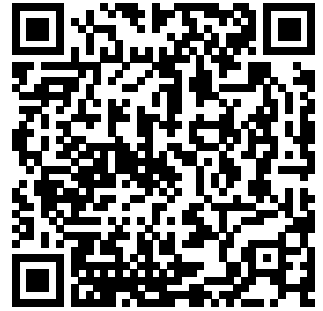
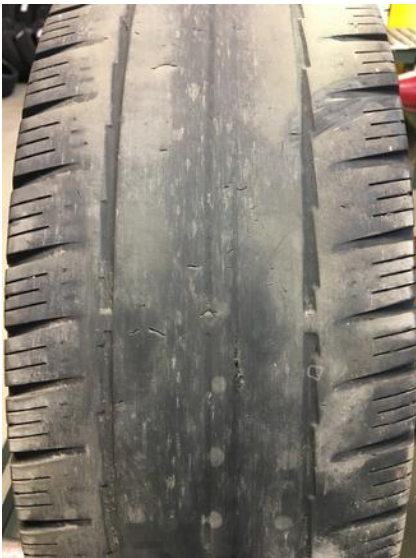
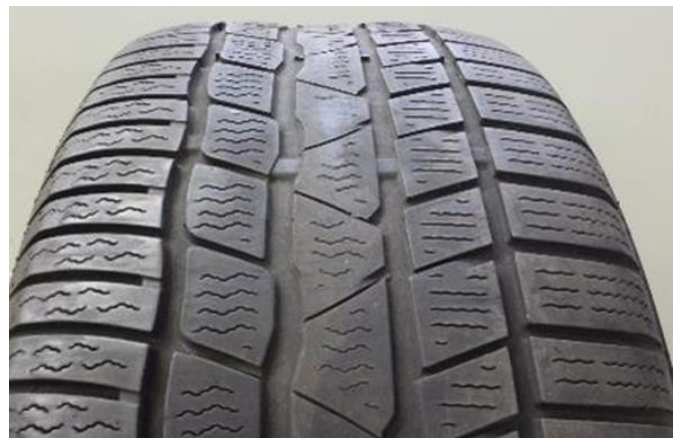
Faster wear of the tread in the center compared to adjacent tread surfaces

- \*Inappropriate inflation (too high) for load being carried
- \*Frequent/permanent driving on straight roads

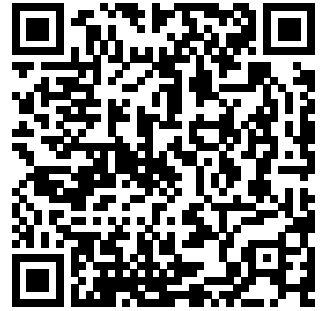
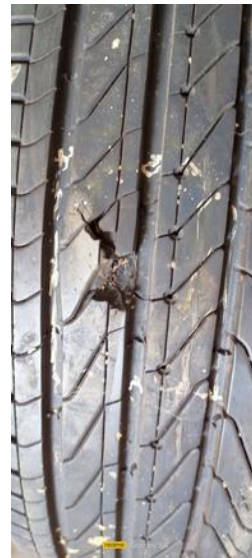
Localized area of damage to the main structure of the tread area. It is a break through the tread rubber and the casing.

Tire tread striking a hard object usually followed by IPL (Instantaneous Pressure Loss). A hard impact compresses the tire, causing the cords or steel belts inside to break

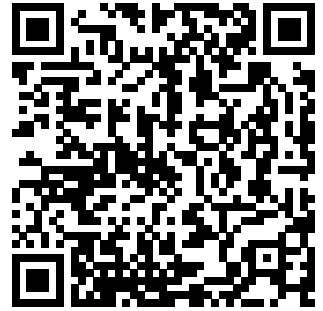
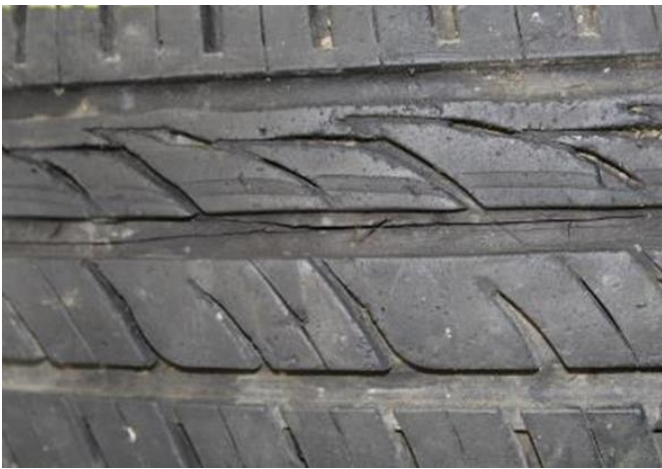
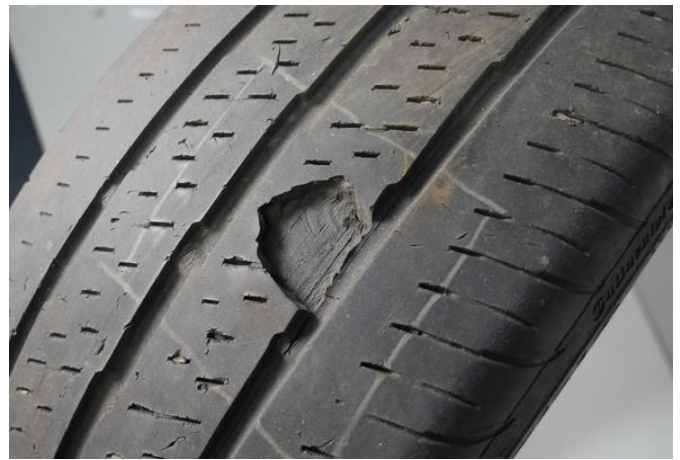
**EN****cut damage (tread)****PLT**

The tire has sustained a cut to the tread from a sharp, foreign object (e.g., glass or metal etc.). This can be manifested in areas of tearing of the rubber compound.

Cut damage is caused by sharp objects and results in slits or tears on the tire surface, which may or may not reach the inner layers of the tire, depending on their depth.

Cut damage is not penetrating through the belt and innerliner of the tire but appearing superficial or a bit more deeper until the innerliner. Tire's integrity remains intact.

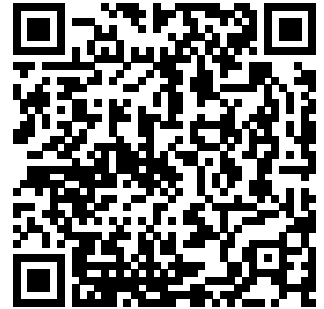
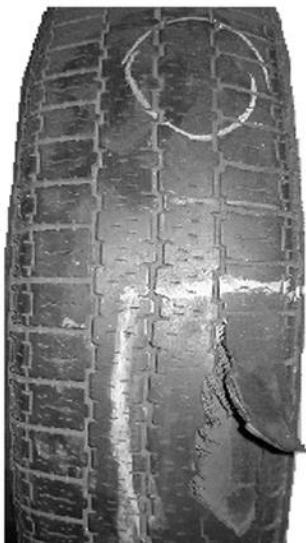
**EN****damaged through deep cuts (moisture-oxidation)****PLT**

The tire has sustained deep cuts by a sharp or a hard foreign object to the tread that reach the steel reinforcing cords (e.g., belt layers)

\*Cut damage through the outer rubber layer reaching out to internal components (e.g., belts) damaging and exposing it to corrosion.

- \*Moisture may cause corrosion in belt wires and separation of internal components.
- \*One may observe localized deformation on the tread area

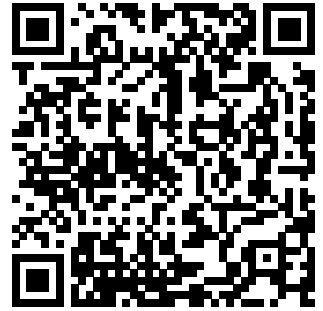
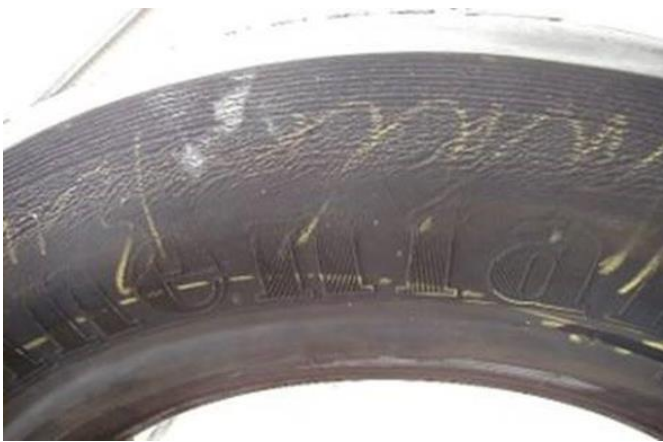
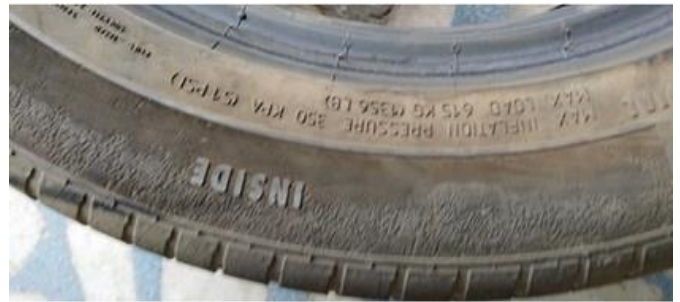
Severe wear has occurred on the tire sidewall through repeated scuffing or curbing.

\*Rubbing against curb stone or guide rails (e.g., during parking)

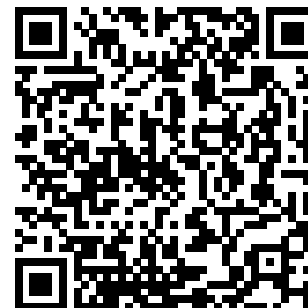
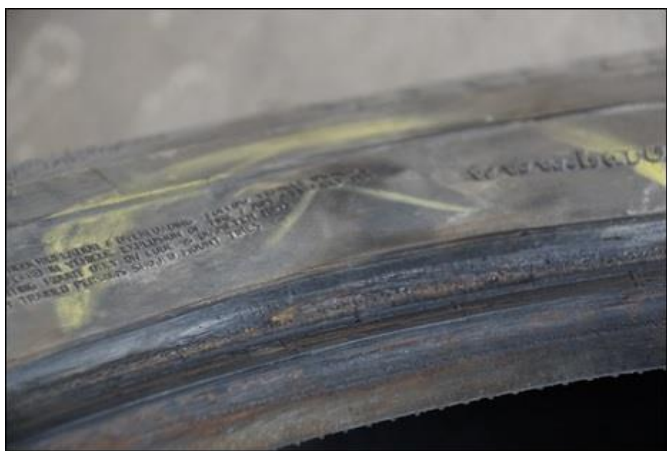
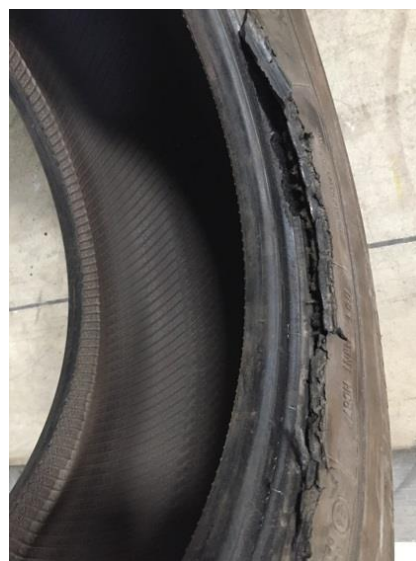
Excessive indentation and chafing marks in the bead area of the tire. The bead area might show a blueish polished surface.

- \*Excessive deflection movement
- \*Underinflation
- \*Overloading
- \*Poor rim conditions

It can be linked to deterioration in the durability of other components in the tire

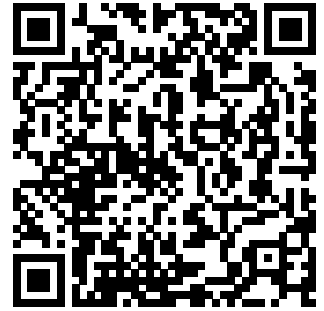
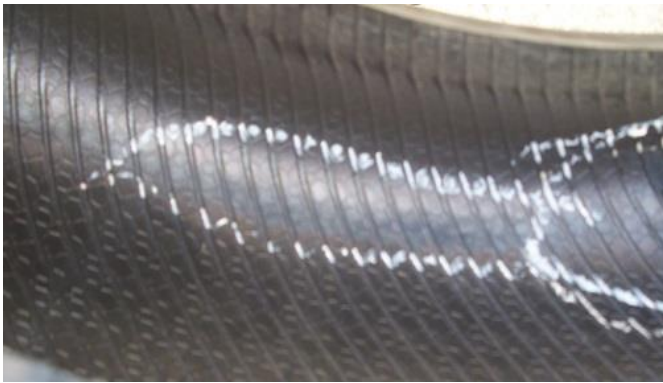
Color changes and/or compression marks are visible on the innerliner

- \*Running in a partially or totally deflated condition
- \*Underinflation
- \*Overloading

Escalating status is CC142.  
Due to the extent of damage any clues to the original cause of deflation cannot be found.  
Any color change or compression marks would be observed circumferentially on the innerliner flexing zone but not localized.

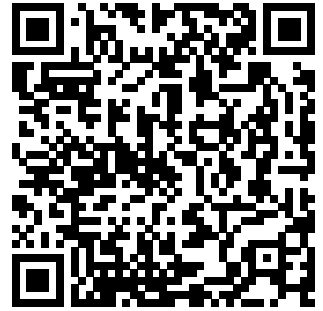
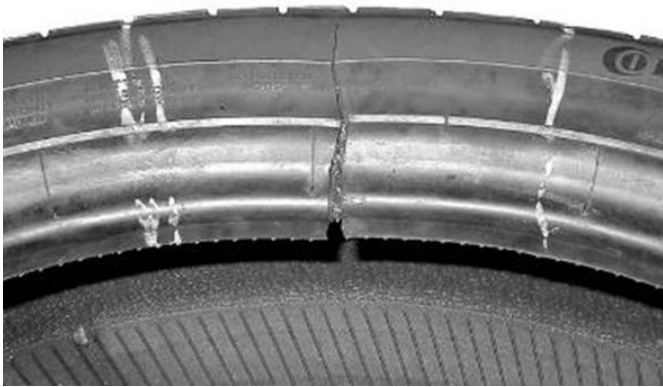
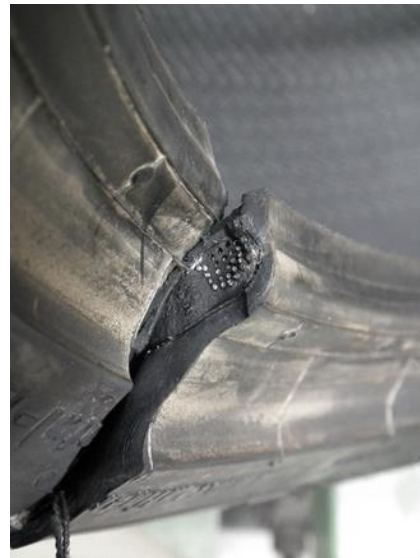
**EN****bead core broken due to mounting****PLT**

A break of the steel bead core. Additionally, a visible crack runs from bead towards sidewall.

- \*"Snagged" on the wheel safety hump during fitting.
- \*Excessive air pressure used to seat the bead against the rim flange.
- \*Inadequate or no usage of lubricant on outer and inner bead area.
- \*Using too much force or incorrect tools during mounting and harming the bead's integrity

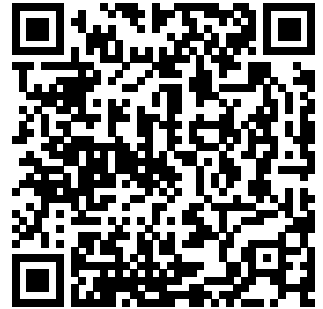
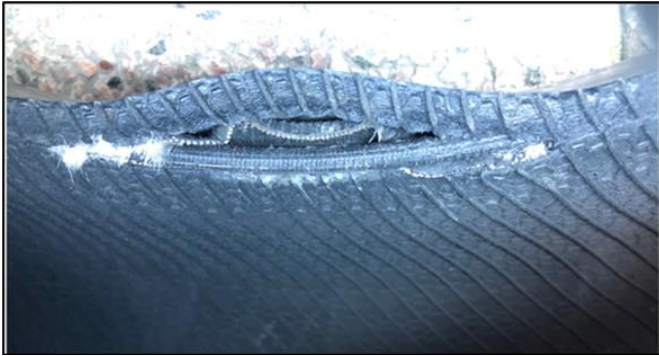
**EN****damaged bead due to mounting****PLT**

The bead of the tire has been locally torn away and signs of separation of internal components can be seen. Dents on local spots due to tools used during mounting maybe observable

- \*Damaged during the fitting operation
- \*Improper usage of lubricants and fitting tools (e.g., sharp edged)

- \*Make sure you examine the inner side of the damage area.
- \*Both outer and inner bead areas are to be lubricated during mounting.

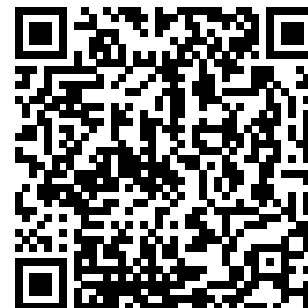
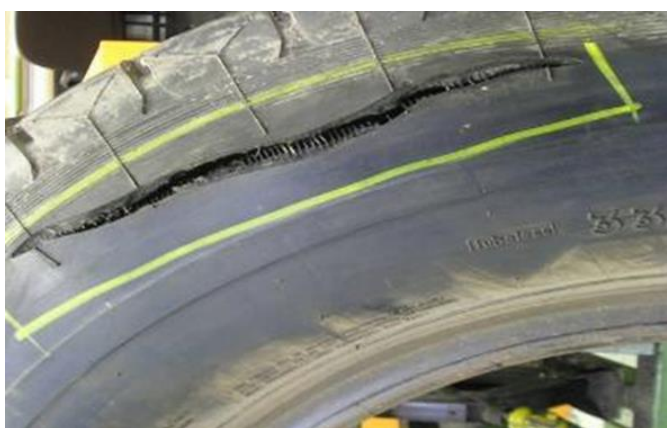
The carcass cords in the flexing zone of a tire are broken or damaged. The sidewall is circumferentially open exposing usually an even line of broken cords.

Cord fatigue (with or without rupture) due to excessive flexing caused by

Tire suffers sudden air loss accompanied with a rupture circumferentially around the tire. However, cord wires may also be fatigue-related damaged without a rupture (handle cautiously when to inflate)  
Happens predominantly in twin-fitment applications. One of the tires is (always) severely underinflated or running flat.

Zipper break condition on new tires is caused by misuse/underinflation (typically in twin application) and therefore this condition is technically rejected (valid for all premium tire manufacturers), by using CC170.

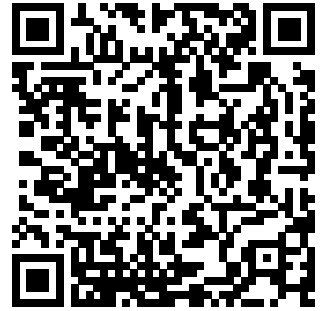
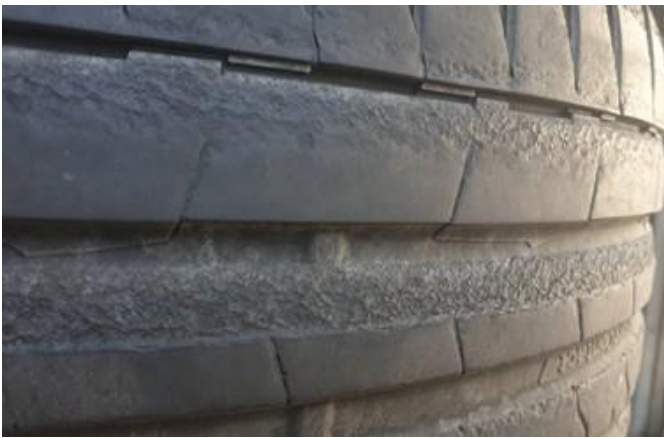
damage due to extreme operating conditions

Extreme operating conditions, e.g., race use of tires which are not foreseen for use in that way

- \*Harsh driving style
- \*Excessive heat generation due to aggressive braking and spinning of the wheel on rough and/or loose road surfaces
- \*High-speed cornering

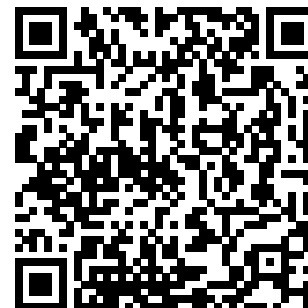
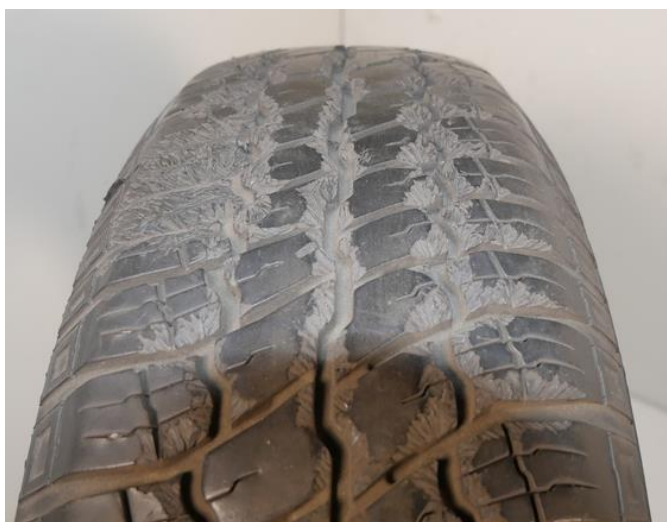
**EN****various other conditions****PLT**

Various other damages that cannot be subordinated to the existing condition codes. These damages are not caused by manufacturing but by external influence.

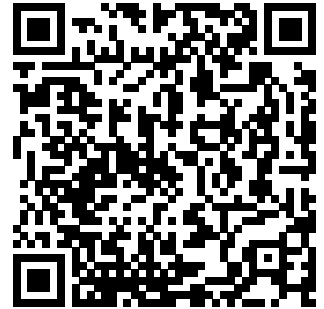
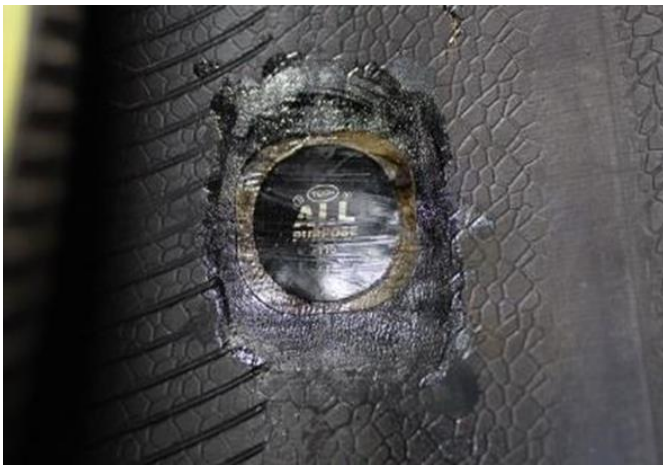
**EN****non group repair****PLT**

The tire has previously suffered a damage which has been repaired. Repair patches are visible.

\*Related to original damage or the repair

Manufacture's responsibility for a tire that is decided to be repaired by a third party specialist voids. For this reason, Continental's warranty is invalidated for any complaints that are associated with a repair.

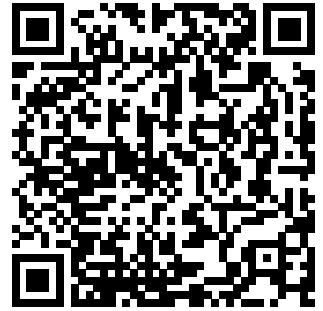
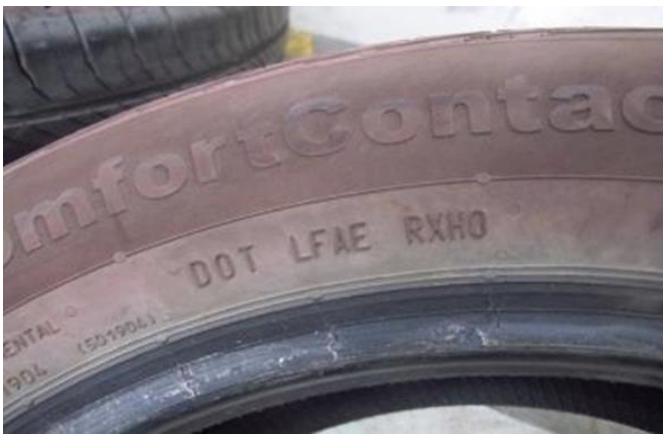
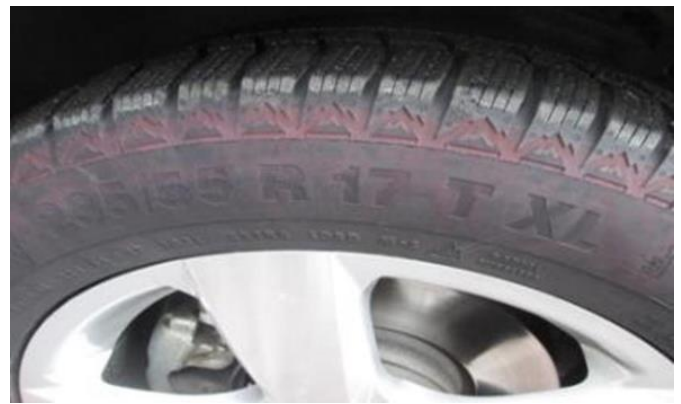
Some discoloration can be observed on tire sidewall which looks red, greyish or off-white waxlike deposits. These deposits are of cleanable nature and have no negative influence on the normal usability of tires.

\*anti-aging agents/ anti-oxidants may diffuse to the surface of the rubber

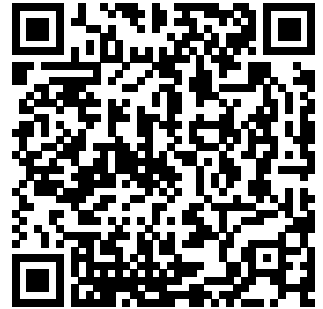
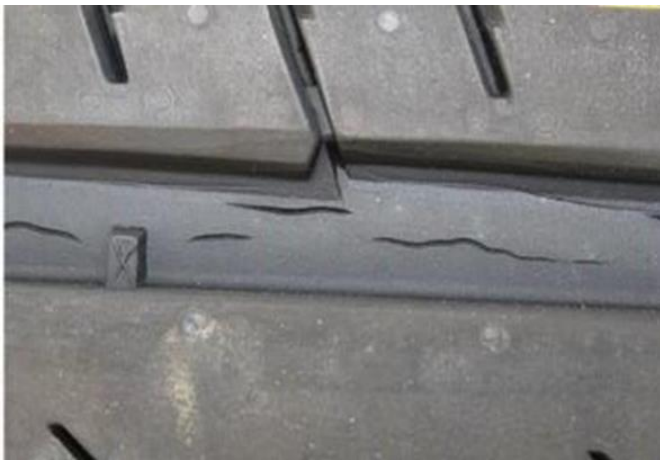
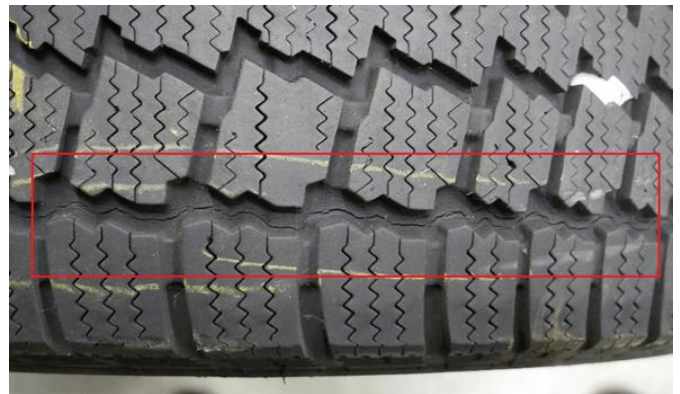
**EN****groove cracking****PLT**

Superficial cracks of not more than 0,5mm deep at the base of the grooves that run circumferentially around the tire.

- 1) Compression folds (superficial and along the contour of groove pattern)
- 2) "Minor" groove cracks (e.g., length  $\leq$  5 mm, depth  $\leq$  3 mm, number  $\leq$  10)
- 3) Moderate or large deep cracks (belt can be visible)

- \*High side forces
- \*Weathering
- \*Exhaust on drive tires
- \*Aggravated by overinflation
- \*Tire has been exposed to ozone

Do not confuse with wrinkles/compression marks/cuts and/or with brittleness cracks (CC114)

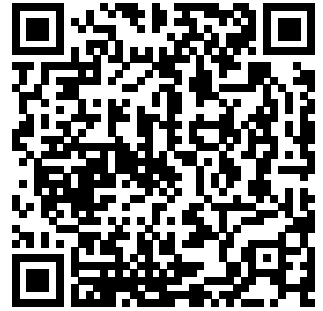
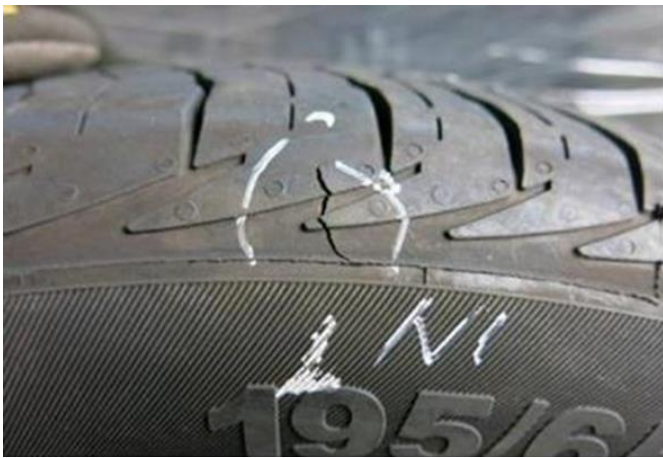
**EN****cracks in the shoulder****PLT**

Cracks in the shoulder area. They are located above or in the mold parting line. The regular flow is typically in circumferential direction. It is shallow, open just from outside. Split surface is plain and it has no traces.

- \*Possible adhesion deficiency between sidewall and tread
- \*Break in flexing zone

Do not mix up with CC123 cut damage (sidewall/shoulder).  
The cracks can occur in circumferential as well as in radial direction.

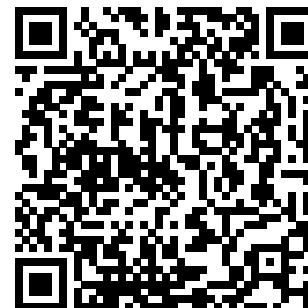
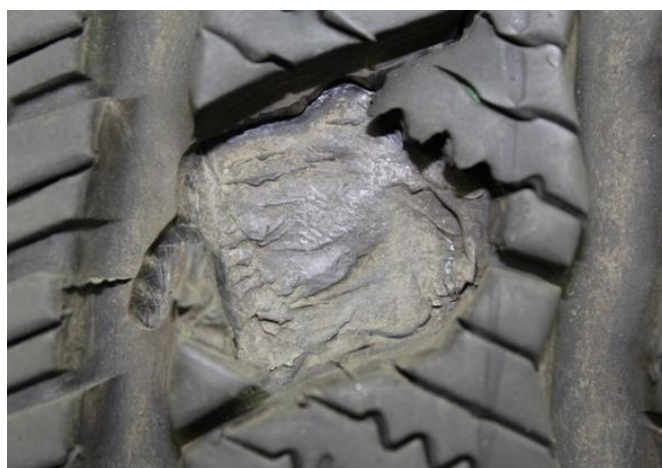
Pattern blocks are torn off at the base of the tread. There are big parts or whole blocks tearing off.

\*Material or demolding process related

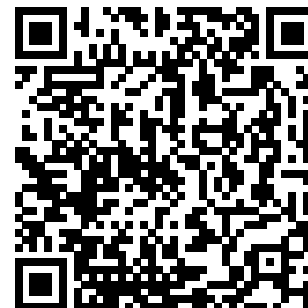
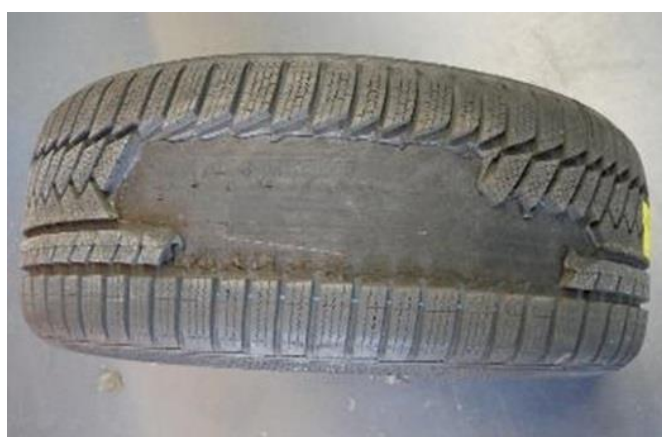
Tread ribs or blocks are not adhered on the belt package. A localized wear on the tread above the separated area can be noticed. One may easily observe a shiny spot underneath the separated tread elements. The belt package is expected to be intact.

\*Adhesion loss between the tread rubber and the tire belt package.

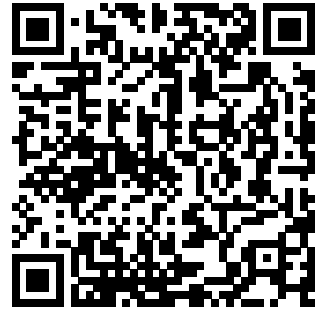
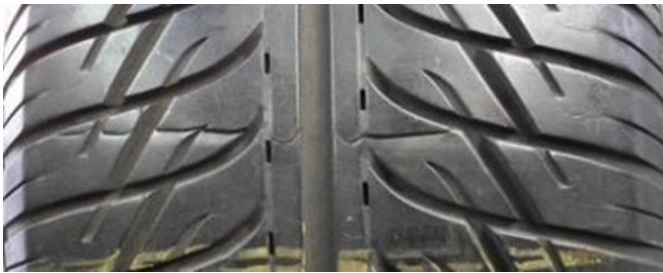
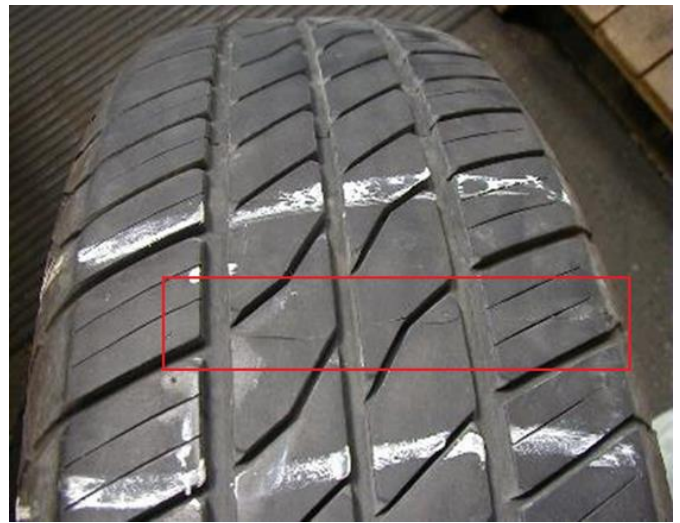
A space is evident on the joint, between the tread ends. Smooth separation is observed with no cuts.

- \*Poor workmanship
- \*Poor tread end adhesion
- \*Tread was cut too short

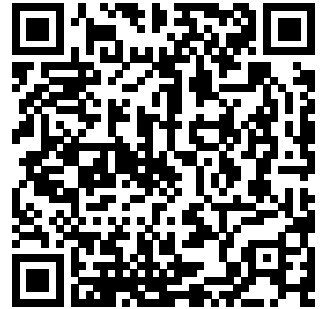
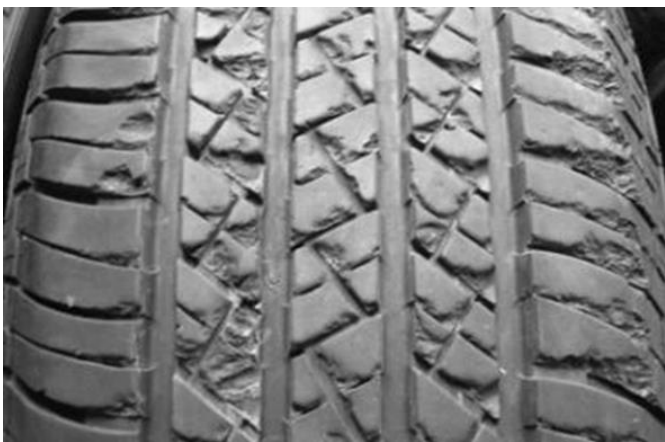
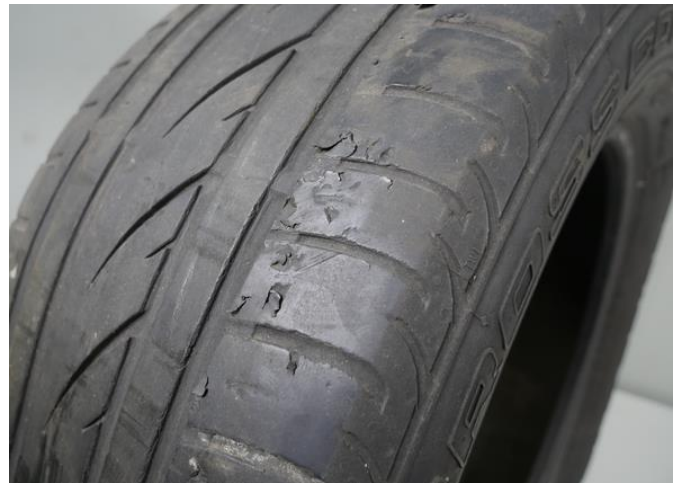
Rough, abraded tread surface with numerous small flakes of tread removed. Hollows appear on the tread surface with rough edges.

\*Material related

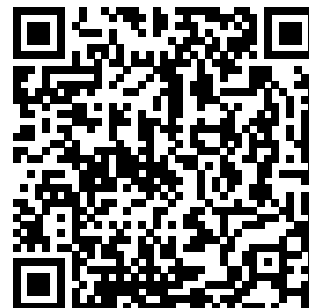
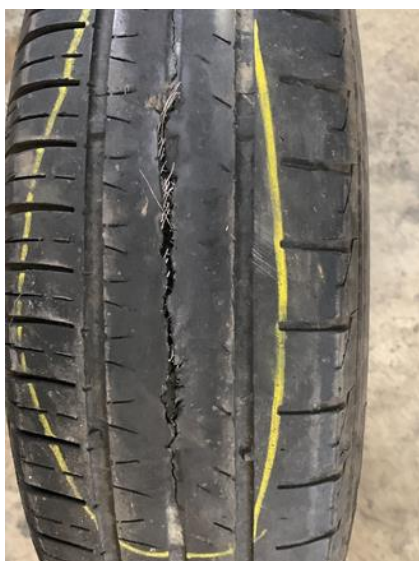
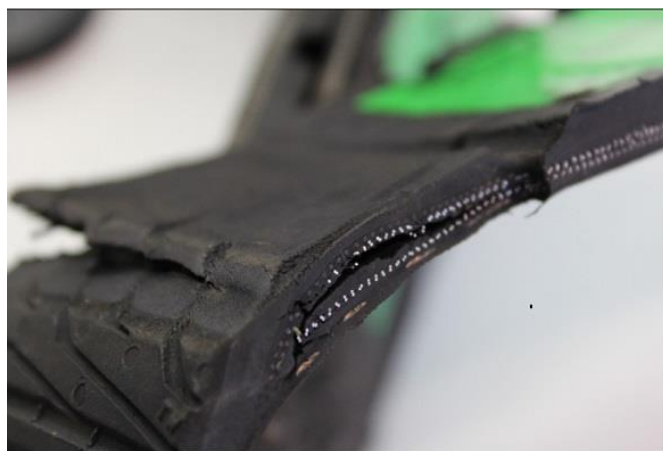
An opening takes place at the shoulder area through which one can see separation between belt layers in the belt package (not between the belt package and the carcass or tread) sometimes with frayed belt edge wires.

\*Adhesion loss within the tire in the belt package

Please check indications or marks for misuse (e.g., underinflation marks such as compression marks on the innerliner, chafing on the bead area or repair) before accepting the complaint.  
Unconfirmed cases (e.g., with bulge on the shoulder area or on the innerliner) should be separately evaluated.

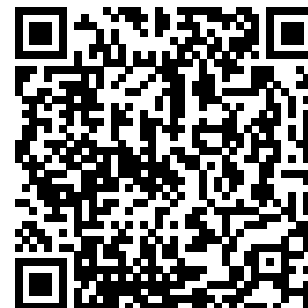
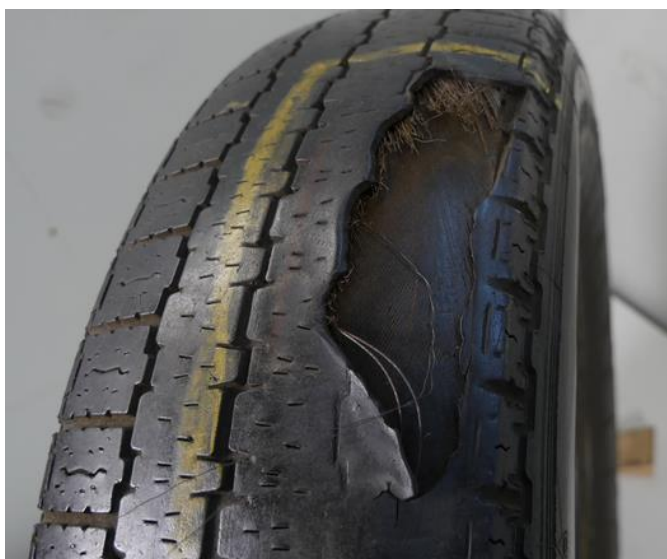
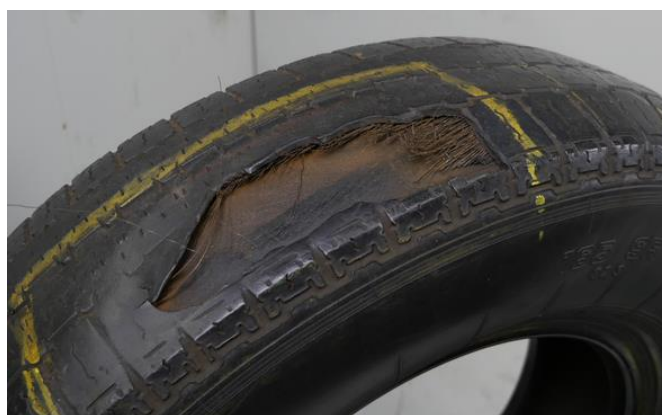
There is a visible separation between the belts. One can see the loss of partial or complete tread/belt package.

\*Adhesion loss within the tire in the belt package

Please check indications or marks for misuse (e.g., underinflation marks such as compression marks on the innerliner, chafing on the bead area or repair) before accepting the complaint.

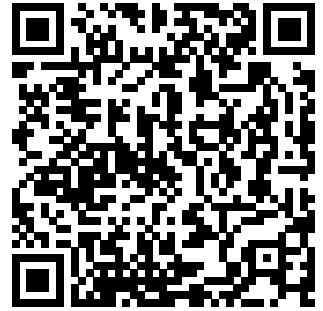
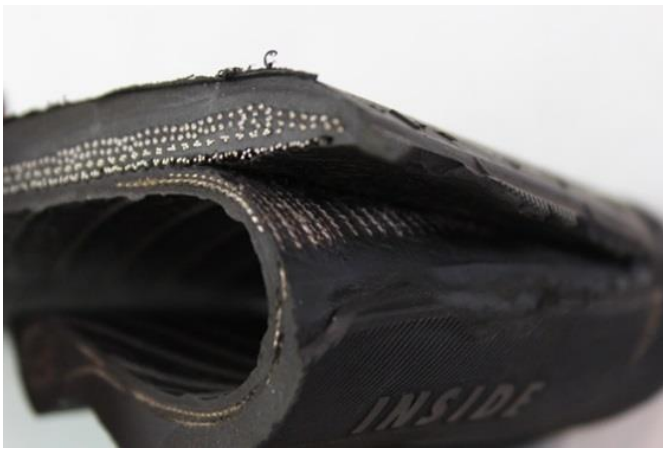
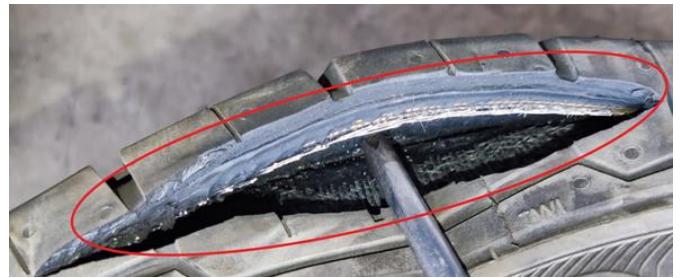
There is visible/confirmed separation between the 1st belt and the carcass.

\*Adhesion loss between 1st belt and carcass.

Please check indications or marks for misuse (e.g., underinflation marks such as compression marks on the innerliner, chafing on the bead area or repair) before accepting the complaint.  
Unconfirmed cases (e.g., with bulge on the shoulder area or on the innerliner) should be separately evaluated.

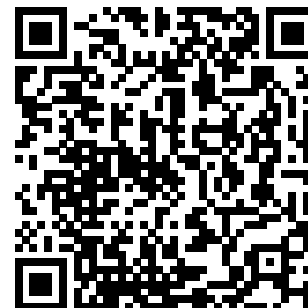
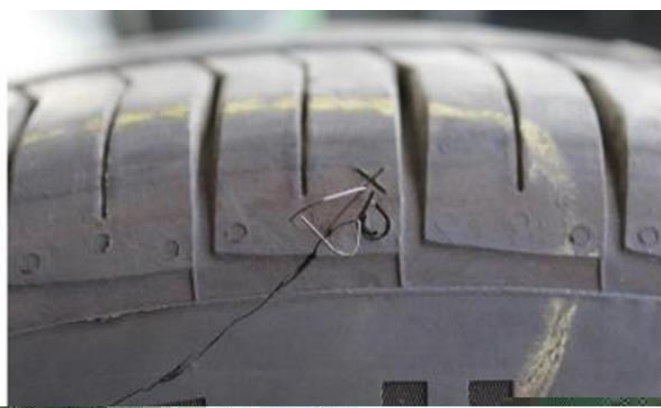
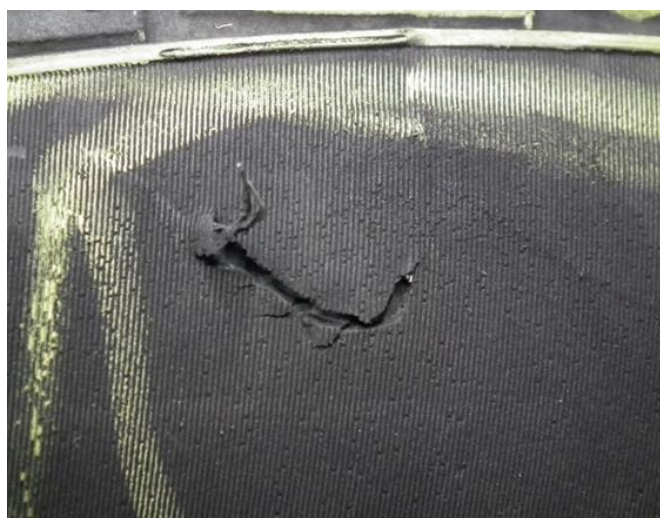
Thin (belt) wires are coming out of the tire without any further visible separation.

\* manufacturing related

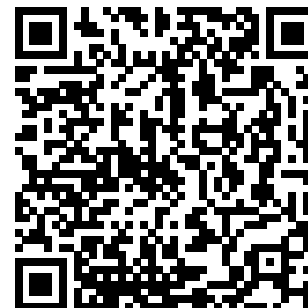
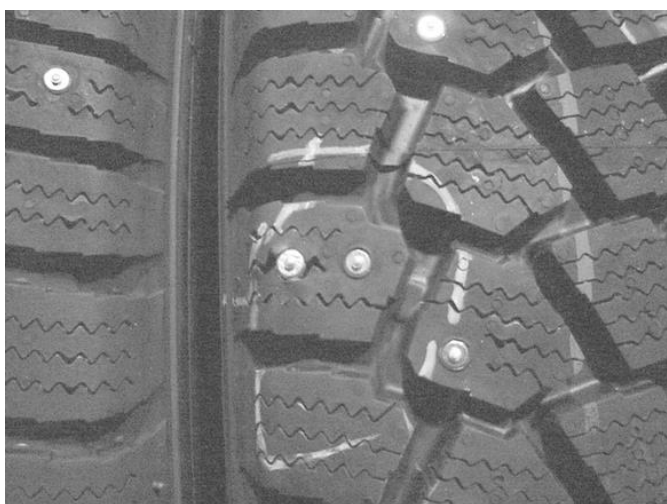
missing spikes / wrongly spiked (new tire)

Spikes setting pattern is irregular. Spikes are missing or wrongly set on a new tire.

\*Manufacturing related

More than 6 spikes missing, add photos or enter number of spikes lost in SAP text field

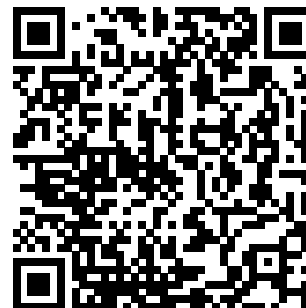
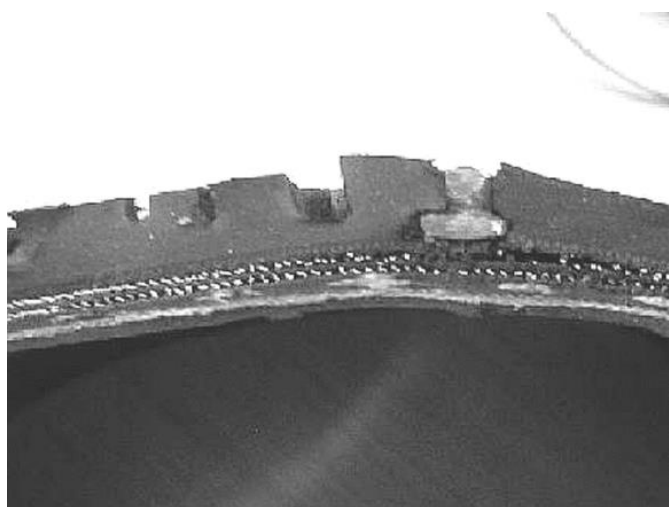
Spikes are set too deep.

\*Manufacturing related

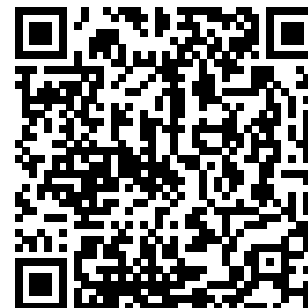
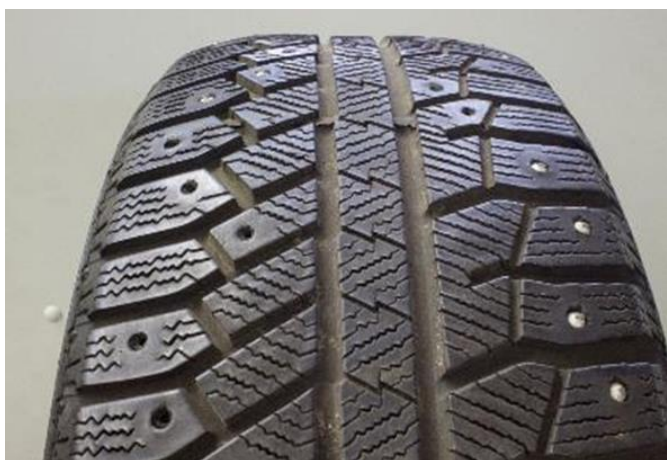
Spikes are missing. On the tread are spots visible, where spikes were located.

\*Design/Manufacturing related

Differentiate this condition from CC116. Be aware of the reference number of accepted loss of spikes. add photos or enter number of spikes lost in SAP text field
