# Examples of Tire Conditions PLT

- › The EoTC is Continental's Tire Division exclusive reference document for tire condition definitions used in the warranty complaint handling process. It serves as a reference for selecting condition codes for complaints / adjustments and is to be applied by trained, qualified persons only (typically by the local TCS organization).

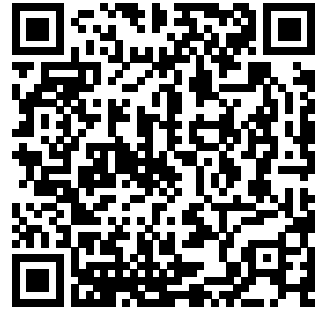
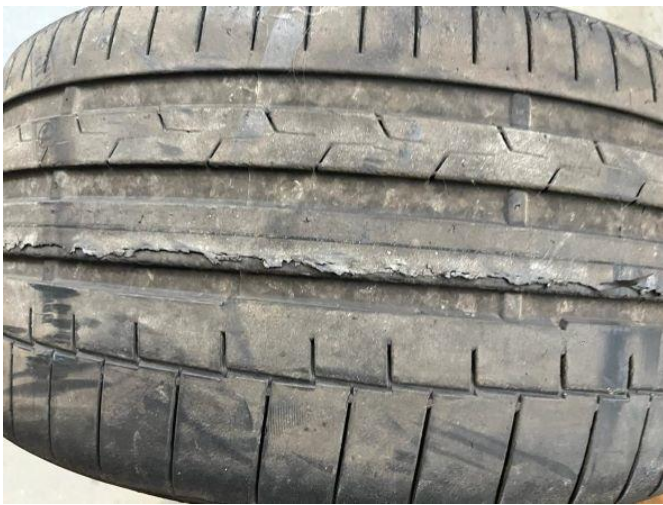
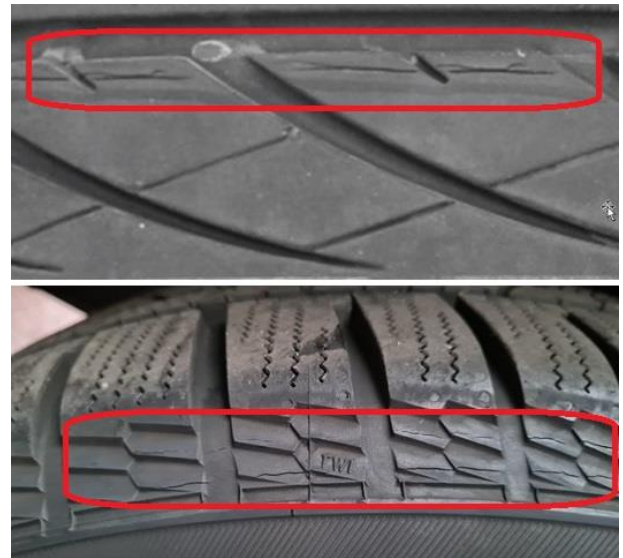
A split like line is observed on the surface usually in a straight line structure which is not in a zigzag shape.

\*Rubber material is not bonded together during the curing process.

A crack is observed with a smooth opening.

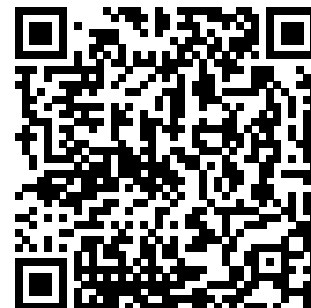
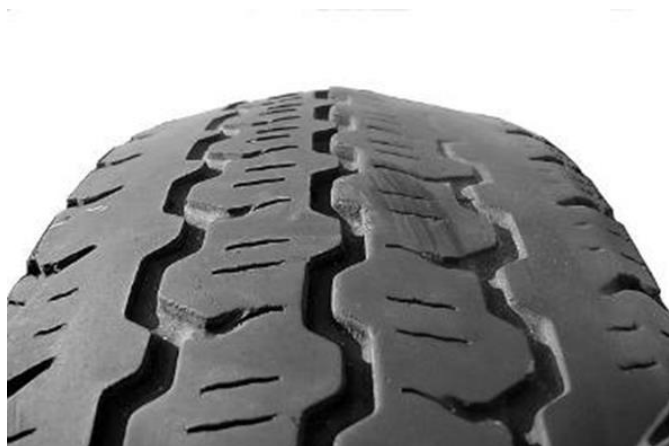
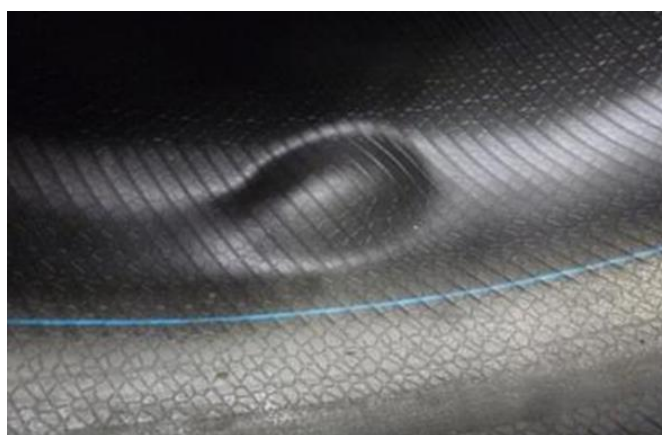
An unconfirmed separation in the tread/belt area that is not yet openly visible.

\*Adhesion loss within the tire in the belt package

Local deformation on tread area and/or accompanied by a bulge in the tread/belt, upper sidewall and/or innerliner, possibly with irregular wear on the tread.

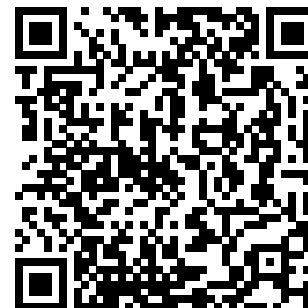
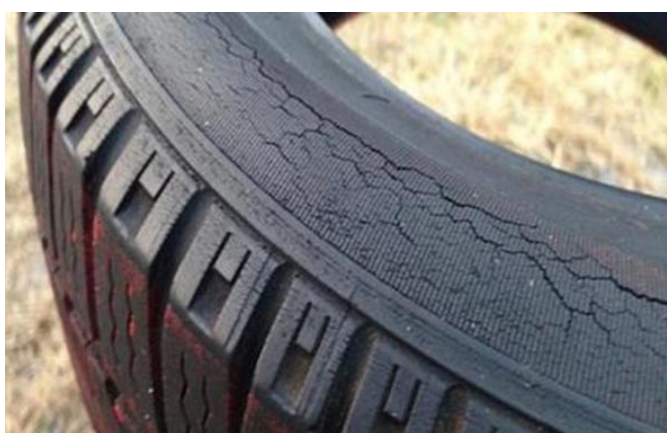
Multiple, often superficial cracks on the sidewall surface generally around the circumference of the tire on one or both sides.

\*Exposure to ozone from sunlight, heat etc.

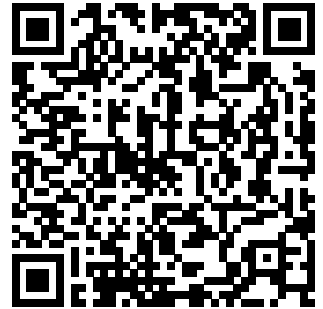
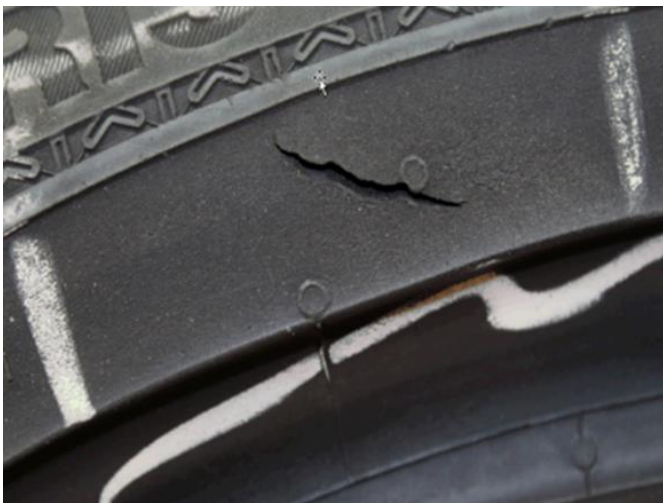
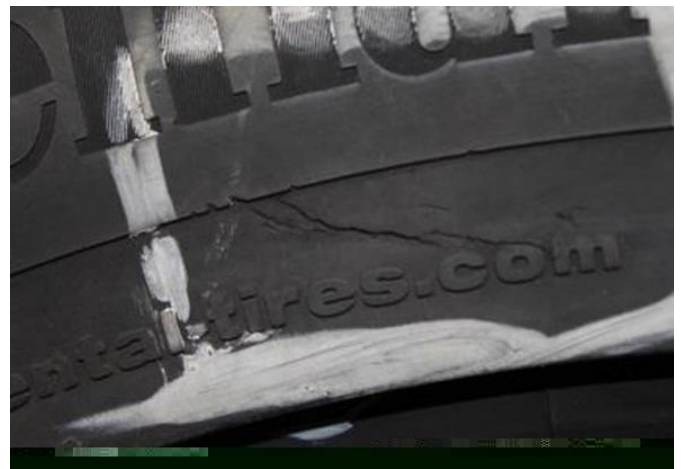
diagonal cracks sidewall (PLT tires only)

Cracks in the mid to upper sidewall that are generally at an angle of 45° to the bead.

\*High torque in combination with specific sidewall compound

Usually multiple cracks appear on the sidewall area.

Check if the finding was not caused by cuts

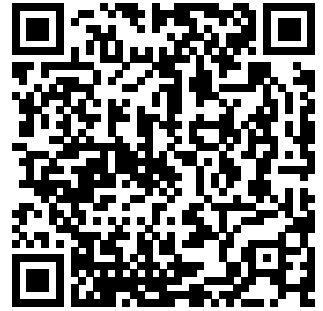
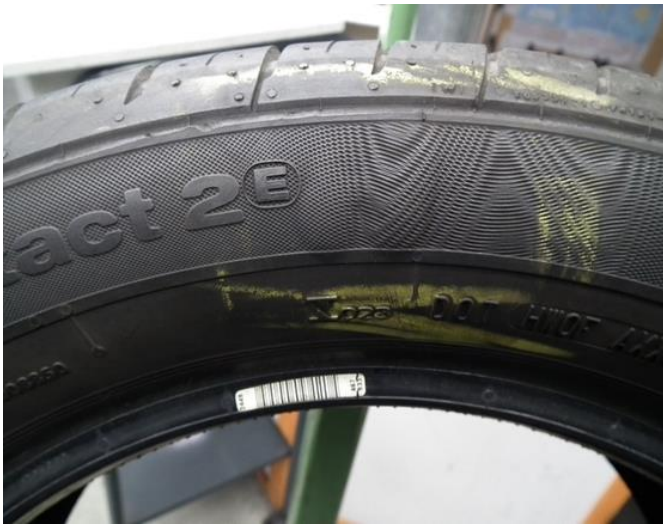
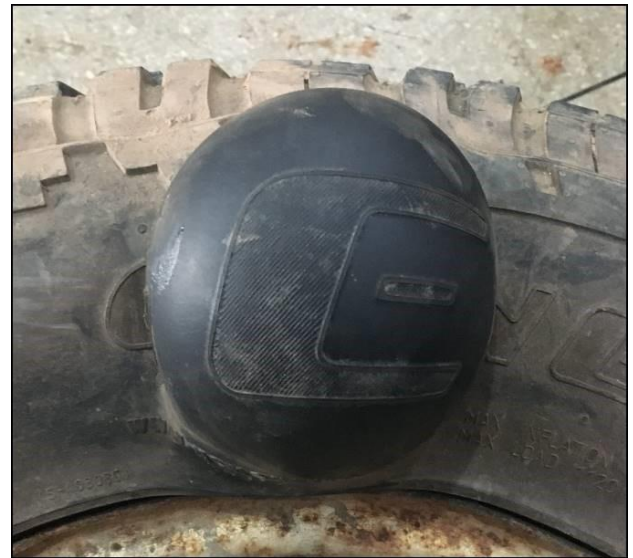
Irregular-shaped bulge in the mid/upper sidewall area; may progress to complete separation of sidewall rubber from the casing exposing the ply cords.

\*Loss of adhesion between the sidewall rubber and the body ply.

No repairs, breaks, punctures or contamination in the casing must be evident.

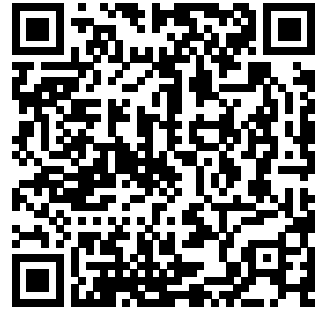
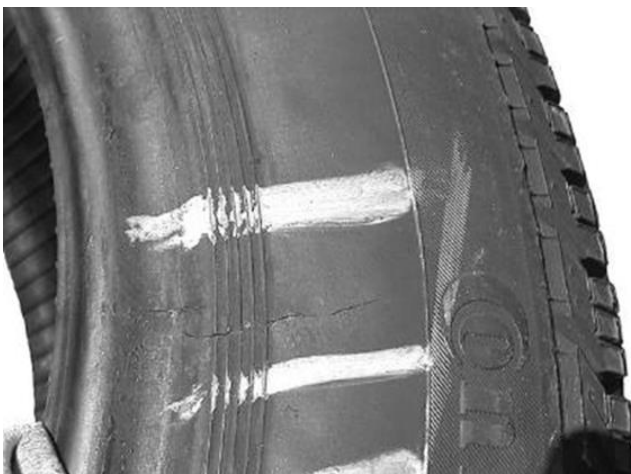
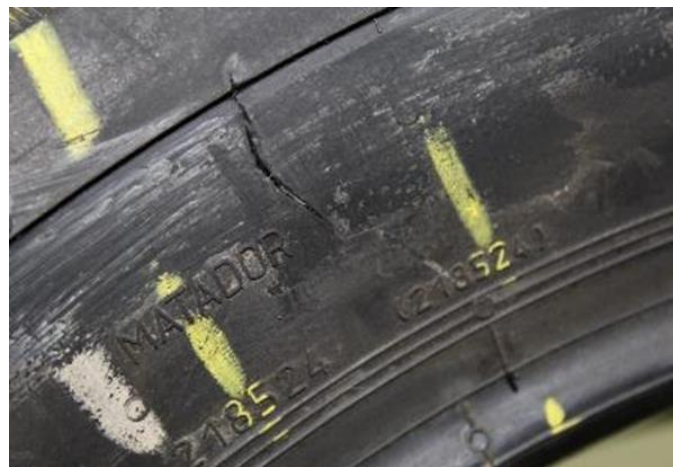
A smooth opening at the joint, of the top layer of sidewall rubber that may appear radially or diagonally. Appearance is similar to a cut, but the opening extends at a sharp angle into the sidewall rubber. No cords are exposed.

- \*Manufacturing process
- \*Poor adhesion during the tire-building process or inadequate curing can result in weak splice joints that may separate over time.

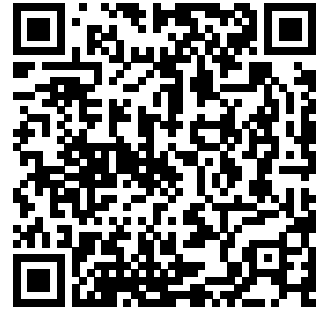
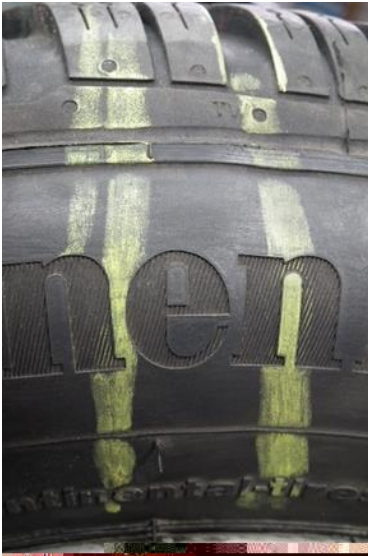
Excessive overlap or uneven application of rubber layers at the splice joint during the tire-building process. A narrow bulge usually at an angle to the bead most often seen when the tire is inflated. The joint tends to run diagonally and not radially along the height of the sidewall. Usually found on both sidewalls opposite to each other.

- \*A heavy overlap of the sidewall rubber splice made during the manufacturing process.
- \*Inconsistent rubber thickness during production can lead to a pronounced splice.

Don't be confused with bumps and bulges associated with potential circumferential (zipper) ruptures or spread/damaged cords.  
You can feel haptically a hard surface.

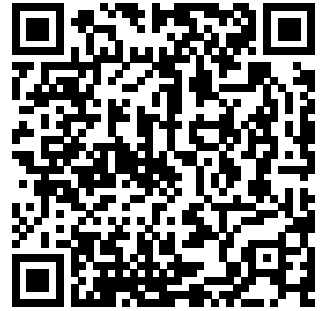
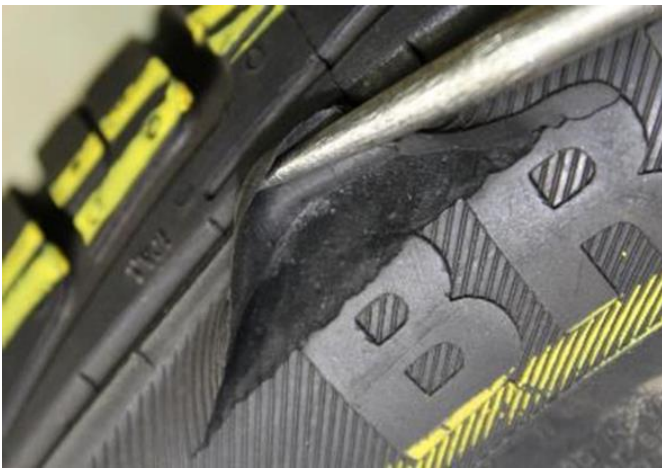
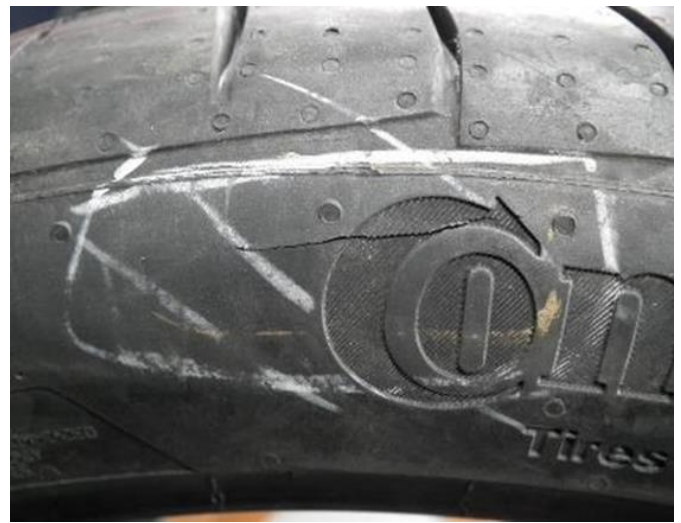
Crack line in upper sidewall area (below or in mold parting line) with covering a long section. The regular flow is typically in circumferential direction. It is shallow, open just from outside. Split surface is plain and it has no traces.

\*Possible adhesion deficiency

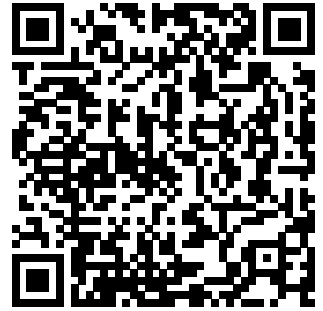
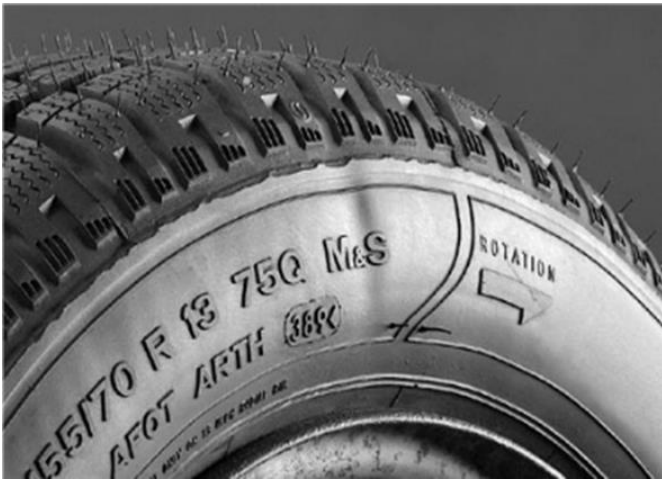
Indentation in a radial direction on one or both sidewalls. Darker marks are visible in the innerliner.

\*Manufacturing related

This can usually only be observed when the tire is inflated and may appear multiple times on the sidewall.

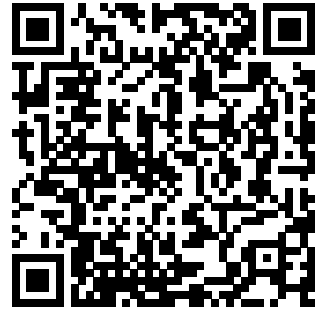
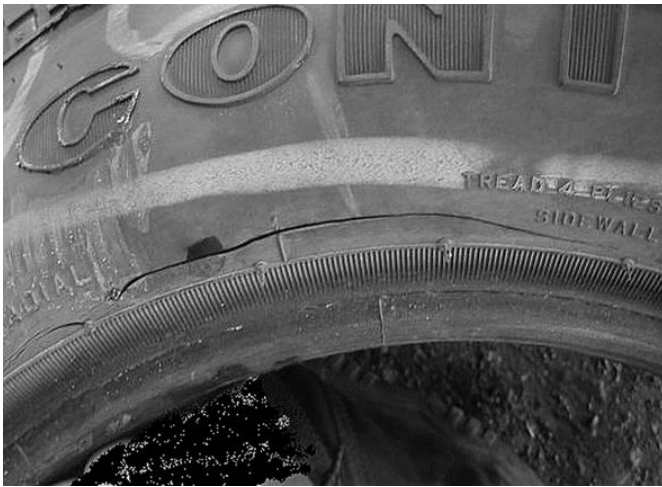
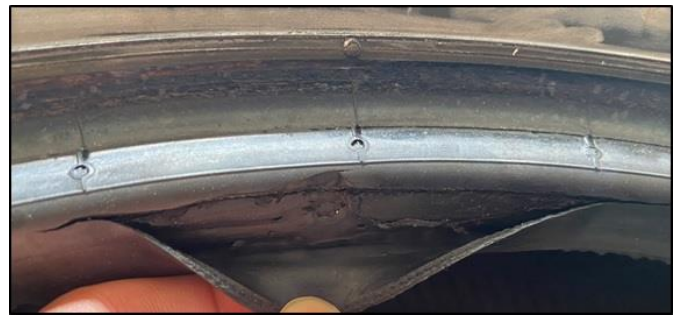
**EN****cracks in the lower sidewall and/or bead area****PLT**

Circumferential crack above the bead/ in the lower sidewall with no wire exposed. The regular flow is typically in circumferential direction. It is shallow, open just from outside. Split surface is plain and it has no traces.

\*Improper rubber flow during the manufacturing process

Crack starts from outside of the tire. Do not mix up with CC560, where the crack starts from the inside. Often caused by a fold over

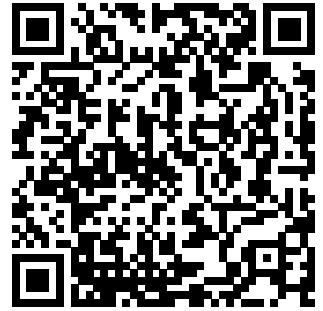
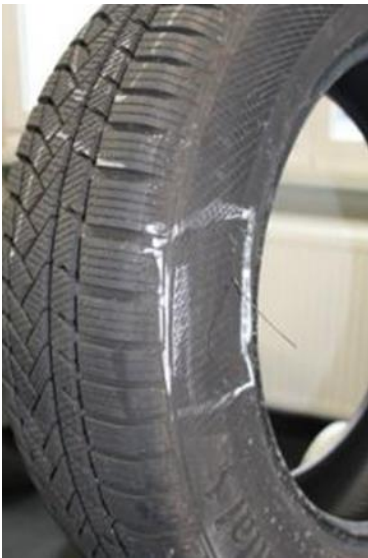
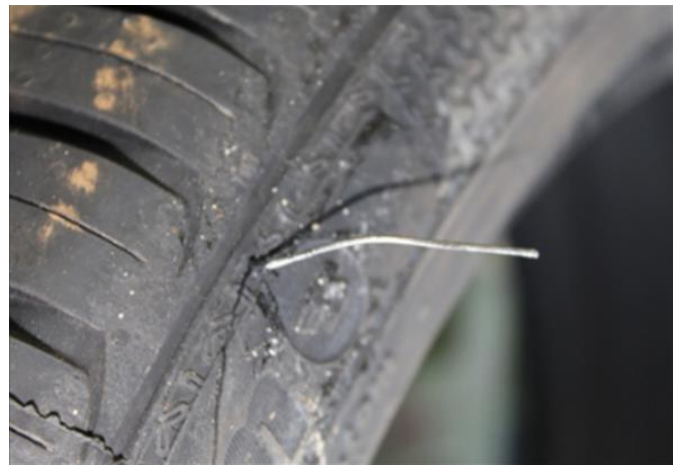
**EN****separated / loose bead wire ending****PLT**

Bead wire (thick) protruding through the exterior or interior surface of the tire.

\*Manufacturing related

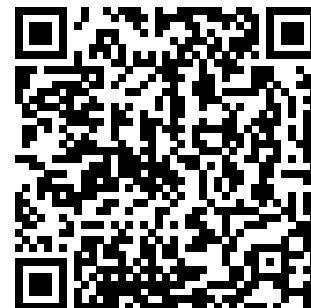
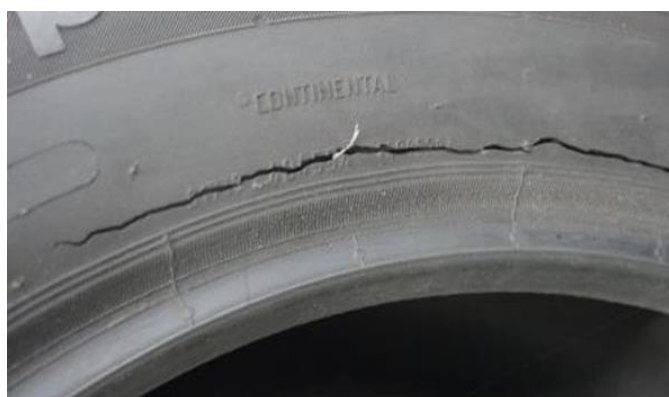
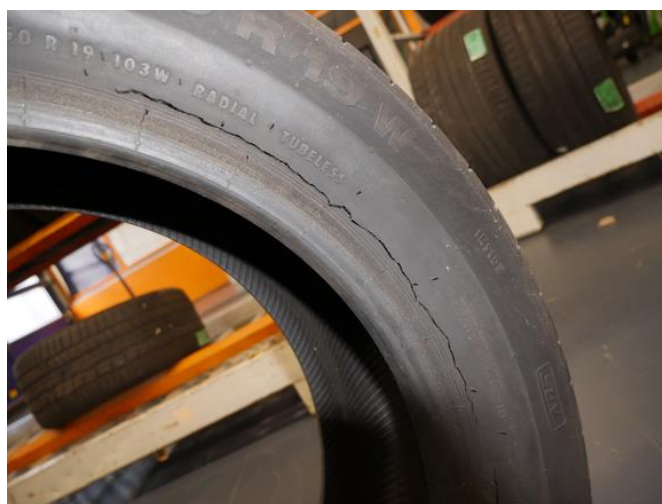
Break, bulge/ separation in lower sidewall/ bead area without any signs of chafing and/or blueish coloring/scorching (i.e., no sign of overload/under inflation). The separation is in a circumferential direction and the flow appears irregular. The surface of the damaged area is irregular and broken/ruptured.

\*Physical force on bead structure exceeded the durability of the bead's material and/or construction (no overload/underinflation)

Do not mix up with CC500, where the crack starts from outside of the tire. Separation starts inside lower-sidewall area. Therefore, it is deep into the structure and can be opened. If not so, the complaint should be rejected by using the appropriate code as CC140.

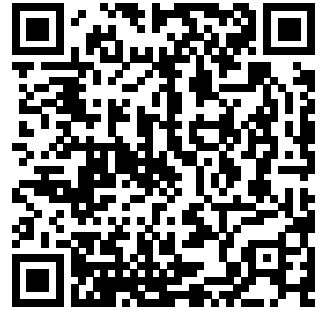
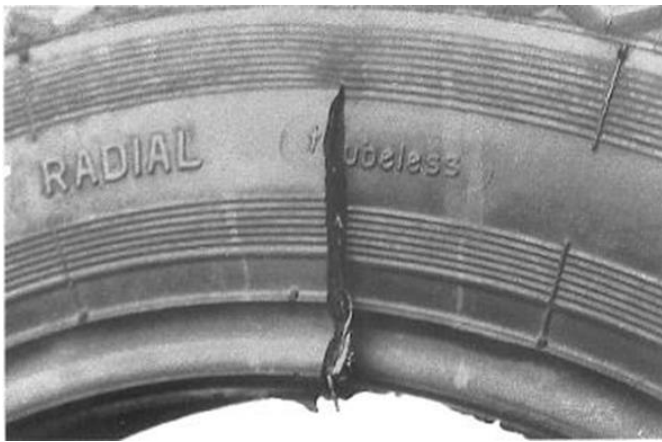
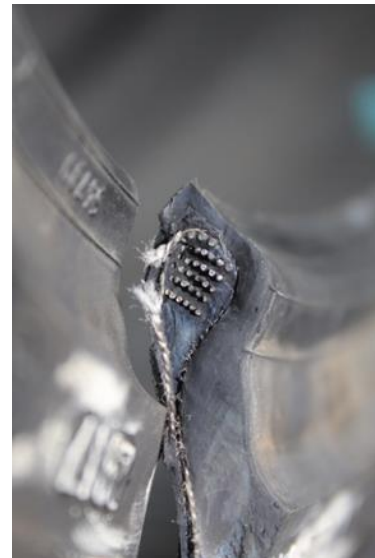
**EN****broken bead core****PLT**

Bead wires are partially or completely broken in a localized area without any signs of chafing and blueish coloring (scorching).

\*Manufacturing related

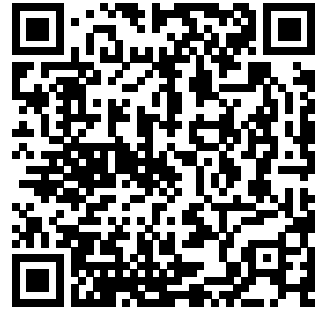
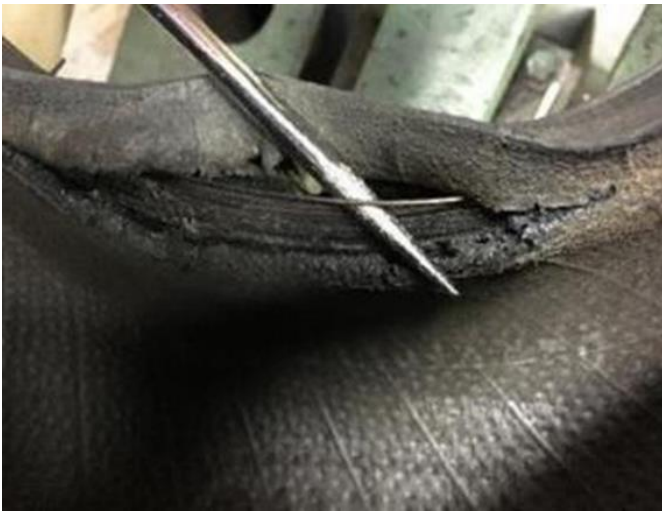
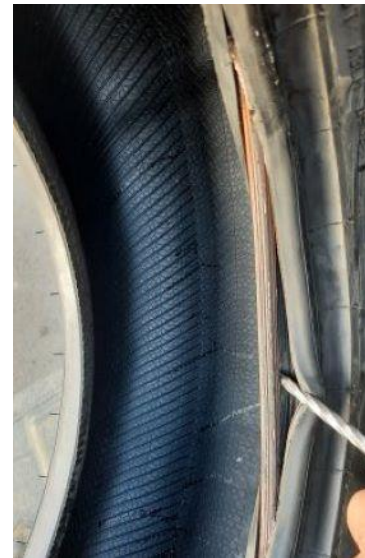
Protruding bead wire bundle.

\*Manufacturing related

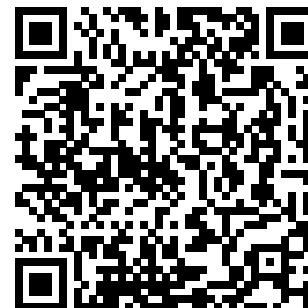
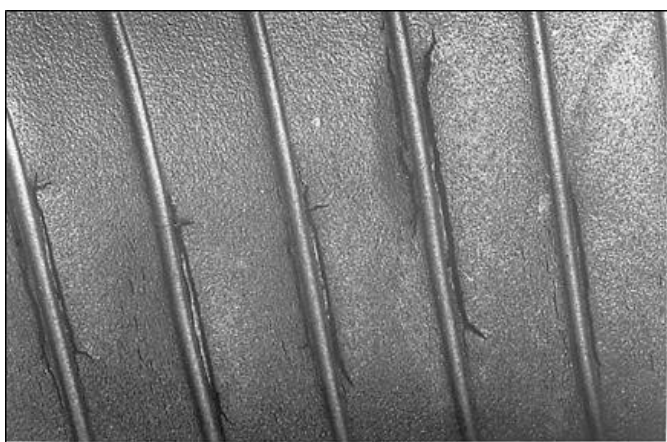
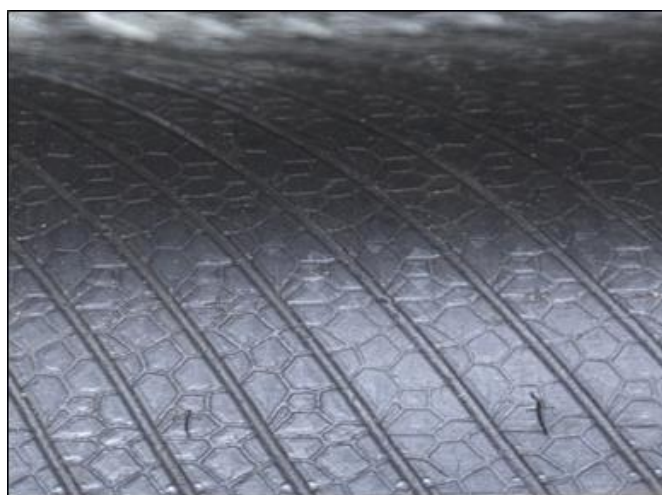
**EN****liner cracks****PLT**

One or more cracks in the innerliner, placed in radial or diagonal direction parallel to bladder lines

\*Manufacturing related

In case of PLT tires, the crack should be radial direction. In case of circumferential direction, CC694 should be used instead.

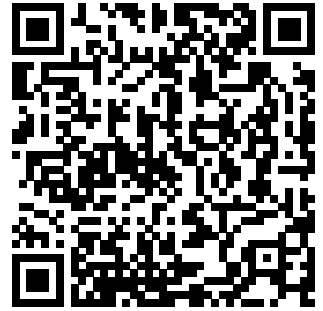
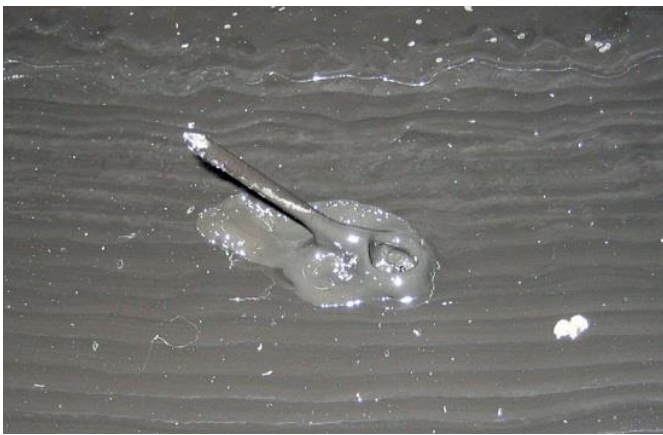
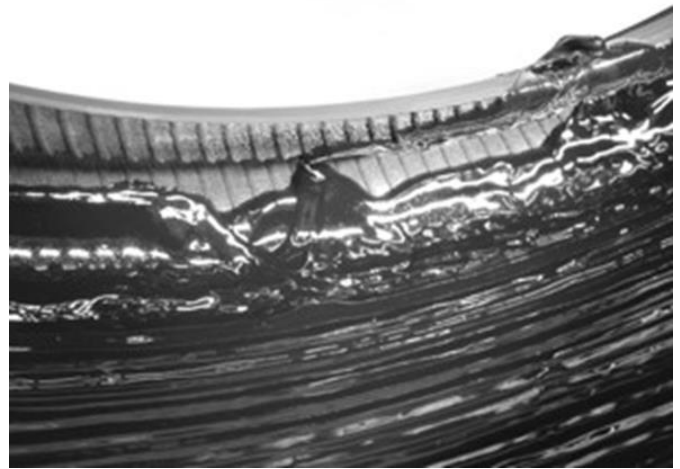
Condition related to sealant features only. e.g., if a puncture featuring a diameter of less than 5 mm is not covered by the sealant, the complaint should be accepted.

Seal functionality not given

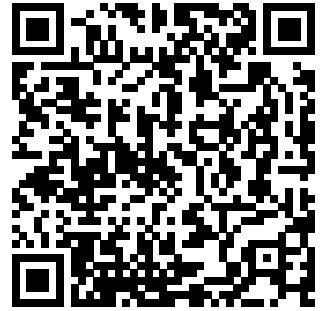
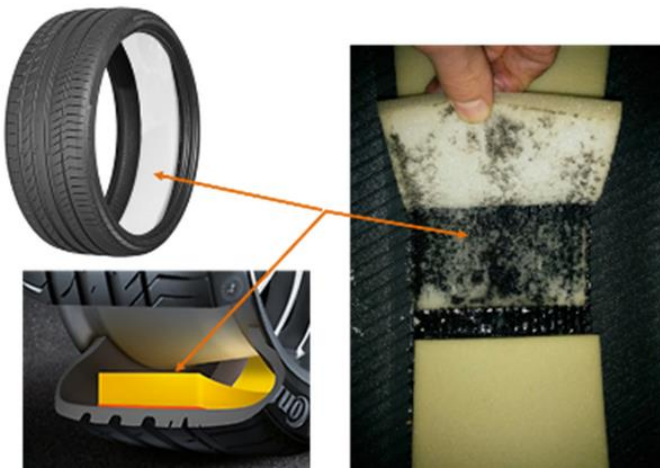
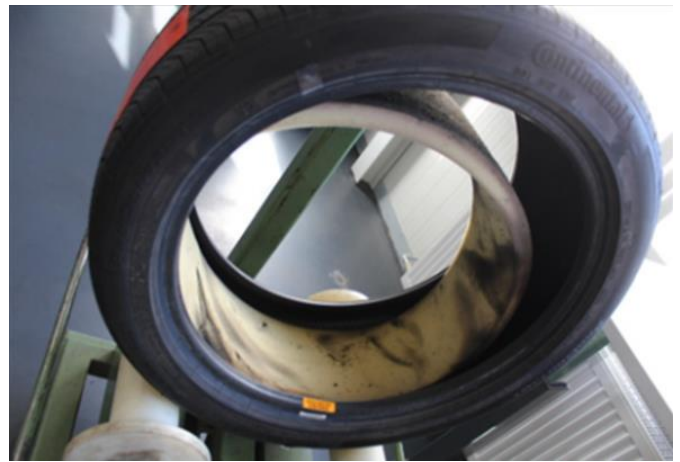
Condition related to silent / foam features only.

\*Low or loose bonding between silent foam and adhesion layer

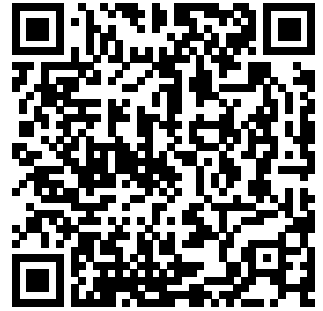
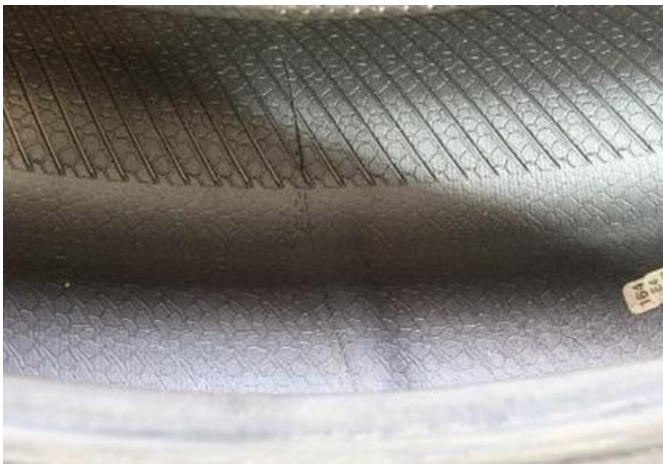
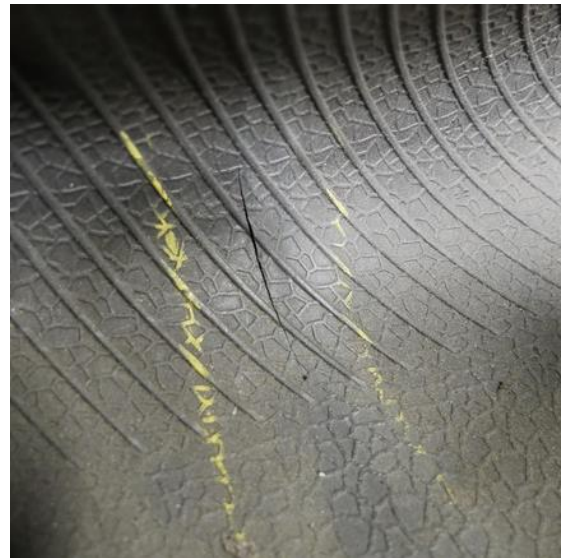
**EN****crack / separation at liner splice****PLT**

An innerliner splice crack is running from one bead to the other. It is a superficial visible disconnection at the joint of the innerliner.

\* From a technical perspective an innerliner splice crack is just a slight opening of the overlapping, not leading to any air leakage.

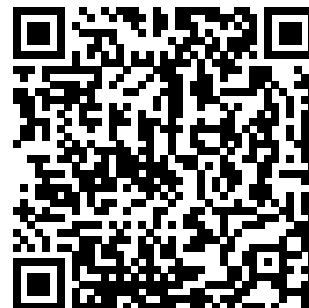
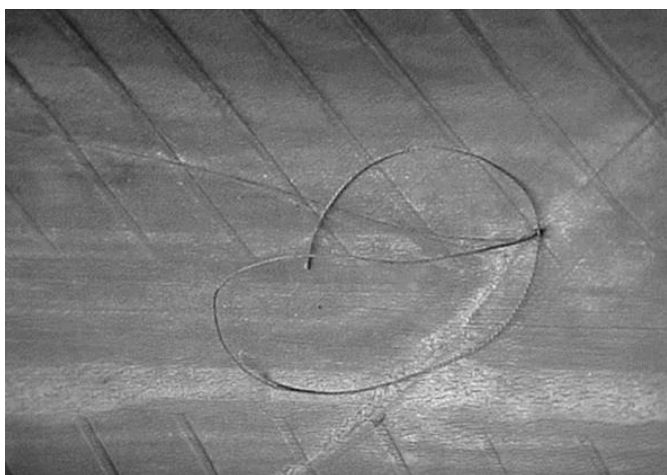
loose carcass cords

Loose carcass cords are visible.

\*Manufacturing related

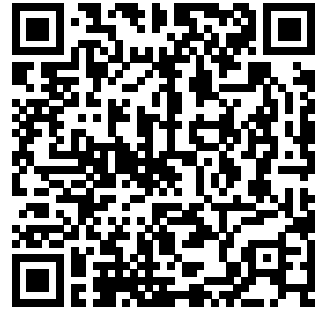
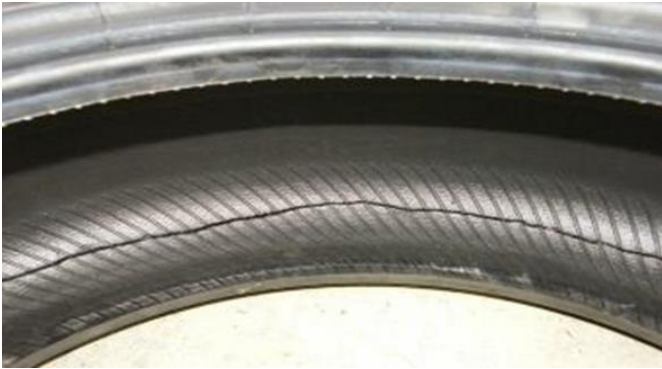
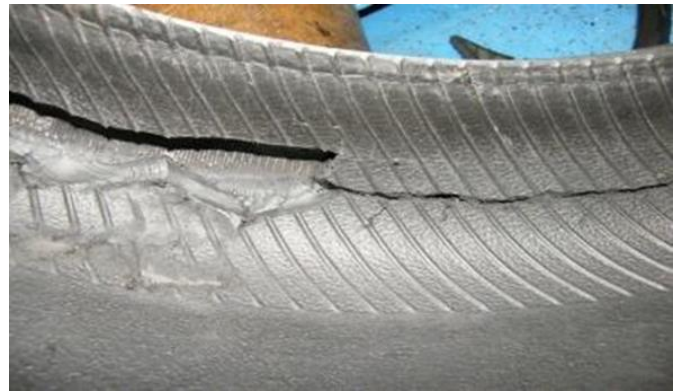
Visible break of SSR insert in flexing zone. In case of any doubt pull sidewall to detect if insert is broken or not.

\*Design related

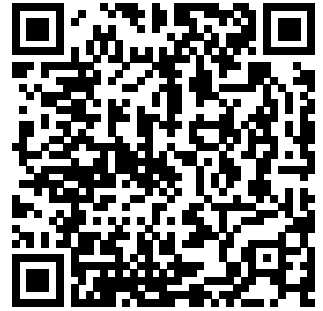
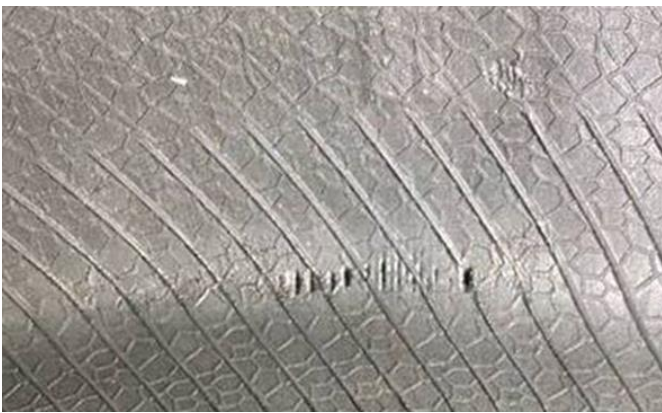
Carcass ply cords penetrating the innerliner sometimes with a bulge (or opening) on sidewall.

\*Manufacturing related

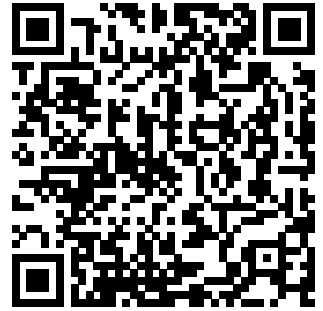
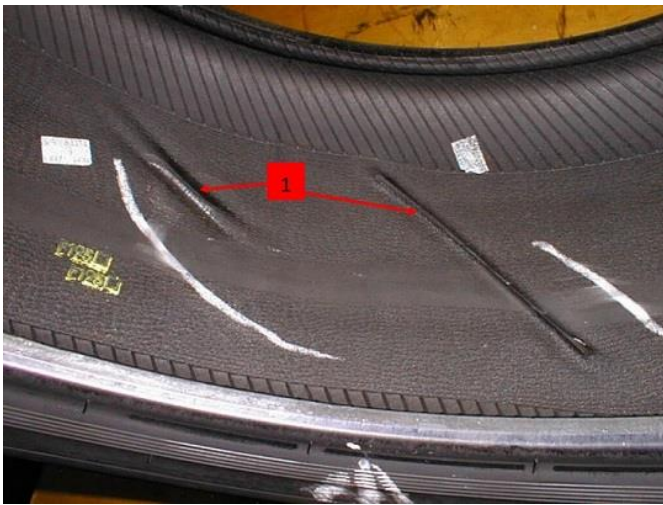
Localized overlapping of material in the carcass.

\*Manufacturing related (curing process)
